14 February 2014

Arboricultural Report

Christchurch Hospital Acute Services Building Development Project

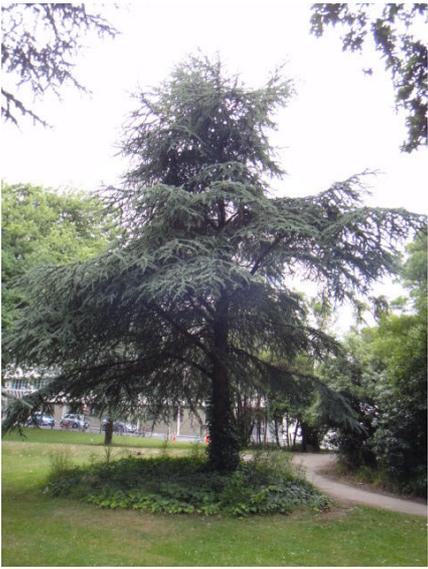
Tree ID:	CH-21

Tree Species:	Blue Atlas Cedar <i>(Cedrus atlantica glauca)</i>	
Protection Status:	Nil	
Age Class:	Semi-Mature	
Height:	13.0m	
Canopy Spread:	11.0m	
DBH:	0.4m	
Health:	3 (Average)	
Form:	3 (Average)	
Overall Condition:	3 (Average)	
Comments:	Tree to be removed. Within vicinity of new building.

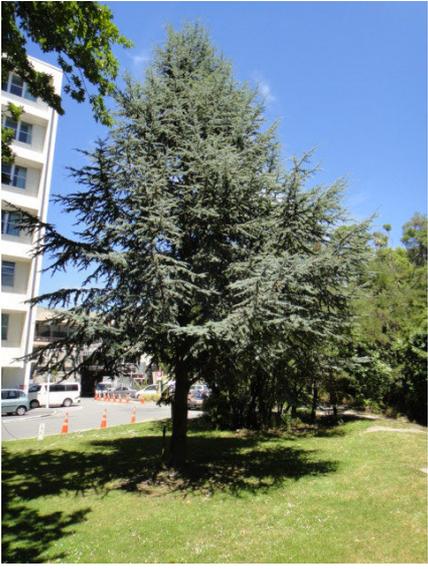
Tree ID:	CH-22

Tree Species:	Blue Atlas Cedar <i>(Cedrus atlantica glauca)</i>	
Protection Status:	Nil	
Age Class:	Semi-Mature	
Height:	11.0m	
Canopy Spread:	9.0m	
DBH:	0.35m	
Health:	3 (Average)	
Form:	3 (Average)	
Overall Condition:	3 (Average)	
Comments:	Tree to be removed. Within vicinity of new building and loading dock.

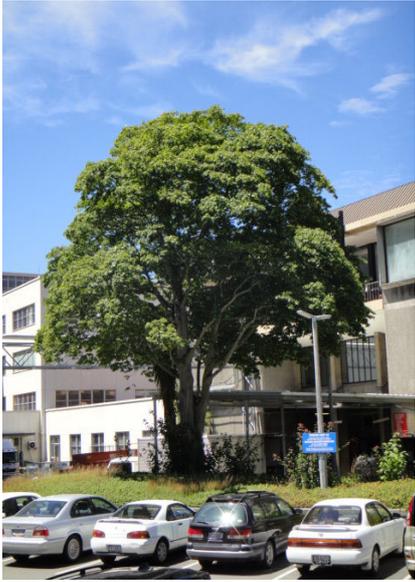
Tree ID:	CH-23

Tree Species:	Sycamore <i>(Acer pseudoplatanus)</i>	
Protection Status:	Nil	
Age Class:	Mature	
Height:	16.0m	
Canopy Spread:	17.0m	
DBH:	0.65m	
Health:	3 (Average)	
Form:	3 (Average)	
Overall Condition:	3 (Average)	
Comments:	Tree to be removed. Within vicinity of new building.

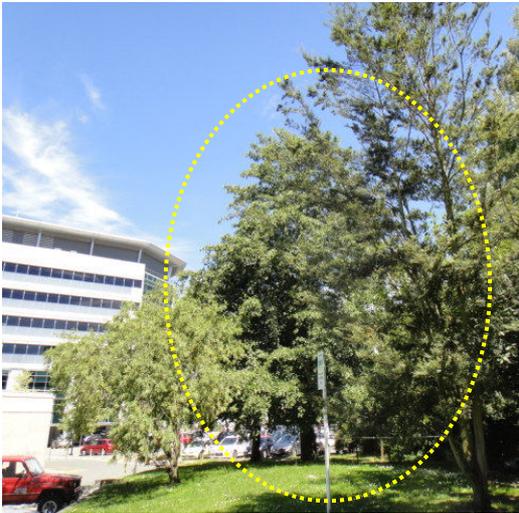
Tree Species:	2 x Alder <i>(Alnus sp)</i>	
Protection Status:	Nil	
Age Class:	Mature	
Height:	16.0m	
Canopy Spread:	12.0m	
DBH:	0.65m	
Health:	3 (Average)	
Form:	3 (Average)	
Overall Condition:	3 (Average)	
Comments:	Trees to be removed. Within new building footprint.

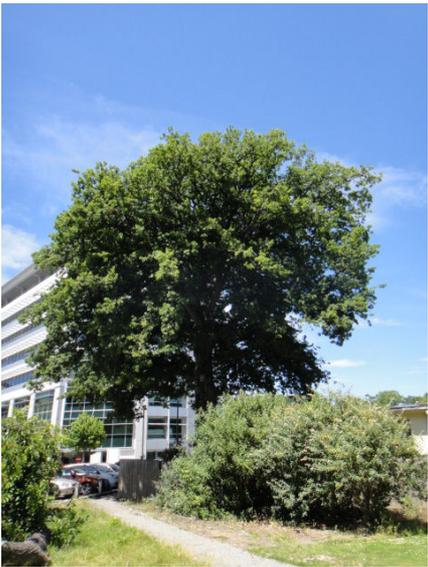
Tree Species:	English Oak (<i>Quercus robur</i>)	
Protection Status:	Nil	
Age Class:	Over-Mature	
Height:	20.0m	
Canopy Spread:	23.0m	
DBH:	1.35m	
Health:	3 (Average)	
Form:	3-4 (Average to Poor)	
Overall Condition:	3-4 (Average to Poor)	
Comments:	Tree to be removed. Within new building footprint.

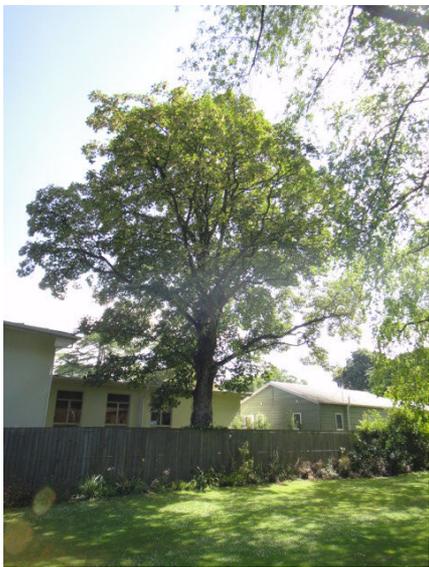
Tree Species:	Sycamore (<i>Acer pseudoplatanus</i>)	
Protection Status:	Nil	
Age Class:	Mature	
Height:	12.0m	
Canopy Spread:	13.0m	
DBH:	0.8m	
Health:	3 (Average)	
Form:	3 (Average)	
Overall Condition:	3 (Average)	
Comments:	Tree to be removed. Within new building footprint.

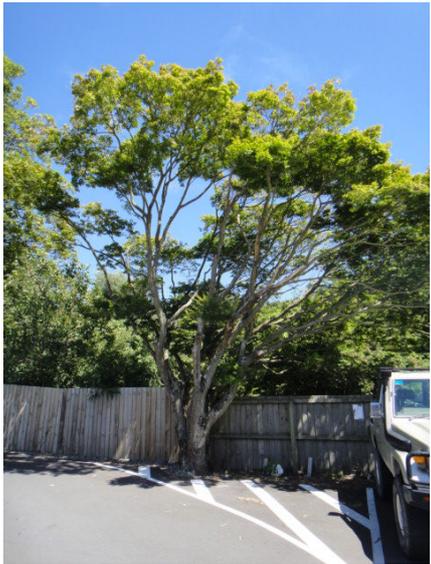
Tree Species:	Japanese Maple (<i>Acer palmatum</i>)	
Protection Status:	Nil	
Age Class:	Over-Mature	
Height:	7.0m	
Canopy Spread:	11.0m	
DBH:	0.6m (at tree base)	
Health:	3 (Average)	
Form:	4 (Poor)	
Overall Condition:	4 (Poor)	
Comments:	Tree to be removed. Within immediate vicinity of new building.

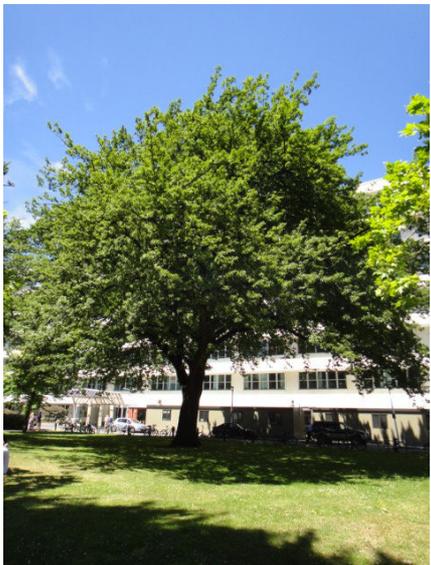
Tree Species:	Turkey Oak (<i>Quercus cerris</i>)	
Protection Status:	Nil	
Age Class:	Mature	
Height:	22.0m	
Canopy Spread:	28.0m	
DBH:	1.2m	
Health:	2 (Good)	
Form:	3 (Average)	
Overall Condition:	3 (Average)	
Comments:	Tree to be removed. Within vicinity of new loading dock.

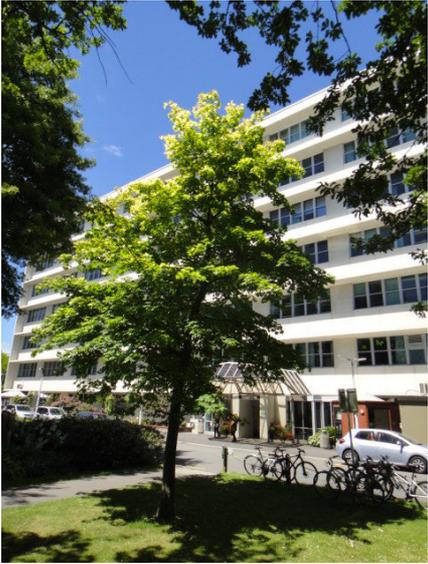
Tree Species:	Maple (<i>Acer sp.</i>)	
Protection Status:	Nil	
Age Class:	Mature	
Height:	8.0m	
Canopy Spread:	6.0m	
DBH:	0.25m	
Health:	3 (Average)	
Form:	3 (Average)	
Overall Condition:	3 (Average)	
Comments:	Tree to be removed. Within vicinity of new loading dock.

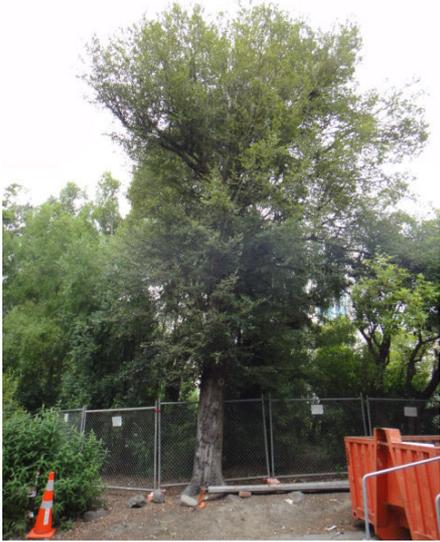
Tree Species:	Red Beech (<i>Nothofagus fusca</i>)	
Protection Status:	Nil	
Age Class:	Over-Mature	
Height:	7.0m	
Canopy Spread:	11.0m	
DBH:	0.6m (at tree base)	
Health:	3-4 (Average to Poor)	
Form:	3-4 (Average to Poor)	
Overall Condition:	3-4 (Average to Poor)	
Comments:	Tree to be removed. Dieback in central stems and sparse foliage density.

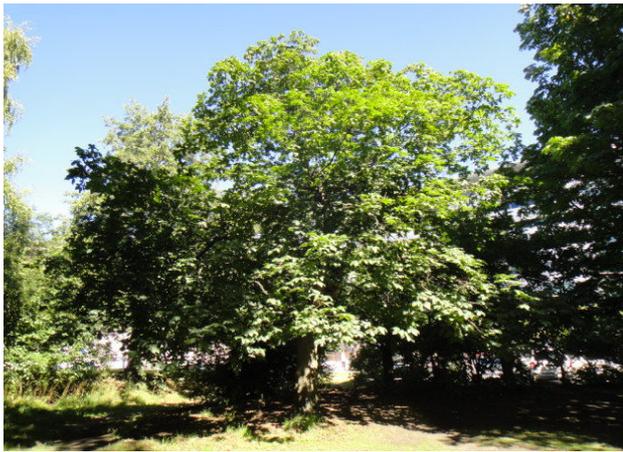
Tree Species:	Pink Horse Chestnut <i>(Aesculus x carnea)</i>	
Protection Status:	Nil	
Age Class:	Mature	
Height:	10.0m	
Canopy Spread:	11.0m	
DBH:	0.42m	
Health:	2 (Good)	
Form:	3 (Average)	
Overall Condition:	3 (Average)	
Comments:	Tree to be removed. Within new building footprint.

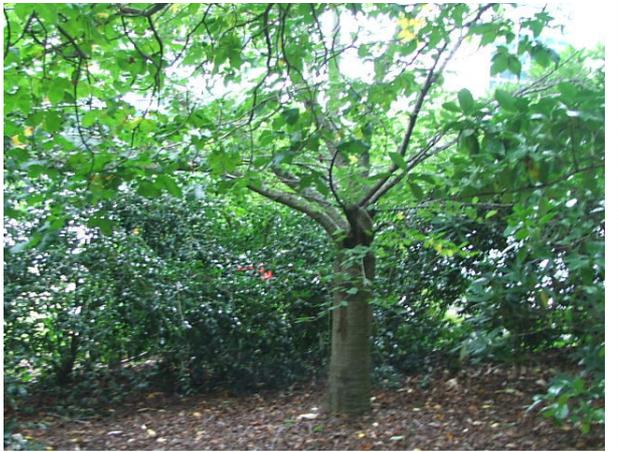
Tree Species:	Yoshino Cherry <i>(Prunus x Yedoensis)</i>	
Protection Status:	Nil	
Age Class:	Mature	
Height:	6.0m	
Canopy Spread:	7.0m	
DBH:	0.31m	
Health:	3 (Average)	
Form:	3 (Average)	
Overall Condition:	3 (Average)	
Comments:	Tree to be removed. Within new building footprint.

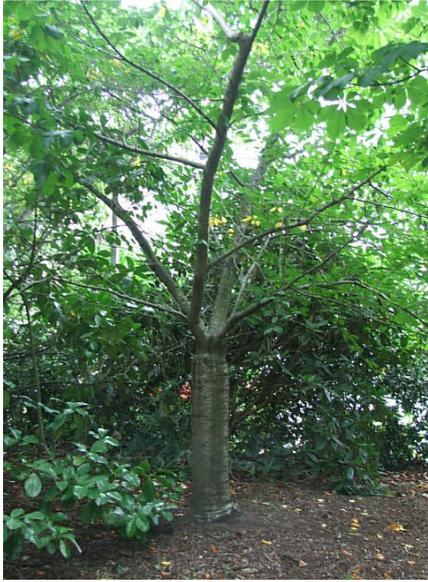
Tree Species:	Yoshino Cherry (<i>Prunus x Yedoensis</i>)	
Protection Status:	Nil	
Age Class:	Mature	
Height:	6.0m	
Canopy Spread:	7.0m	
DBH:	0.32m	
Health:	3 (Average)	
Form:	3 (Average)	
Overall Condition:	3 (Average)	
Comments:	Tree to be removed. Within new building footprint.

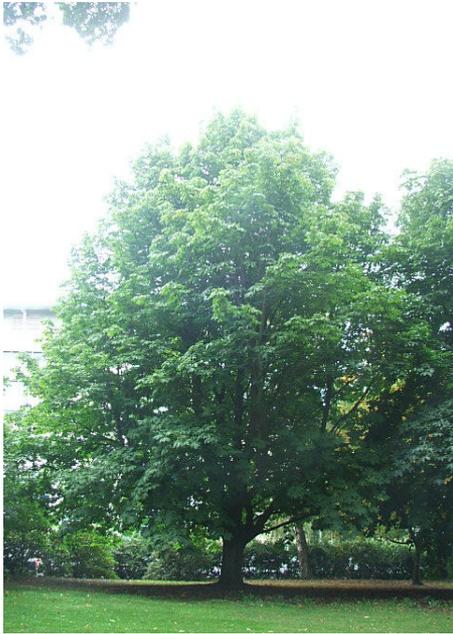
Tree Species:	Baumann's Horse Chestnut (<i>Aesculus hippocastanum</i> 'Baumannii')	
Protection Status:	Nil	
Age Class:	Mature	
Height:	16.0m	
Canopy Spread:	15.0m	
DBH:	0.76m	
Health:	3 (Average)	
Form:	3 (Average)	
Overall Condition:	3 (Average)	
Comments:	Tree to be removed. Within new building footprint.

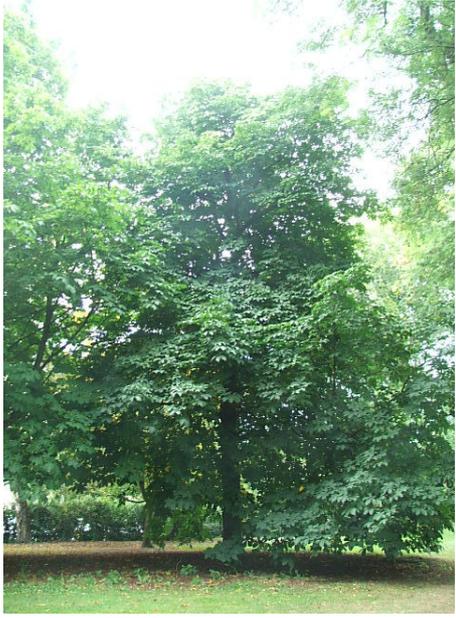
Tree Species:	Horse Chestnut (<i>Aesculus hippocastanum</i>)	
Protection Status:	Nil	
Age Class:	Mature	
Height:	15.0m	
Canopy Spread:	13.0m	
DBH:	0.55m	
Health:	2 (Good)	
Form:	3 (Average)	
Overall Condition:	3 (Average)	
Comments:	Tree to be removed. Within new building footprint.

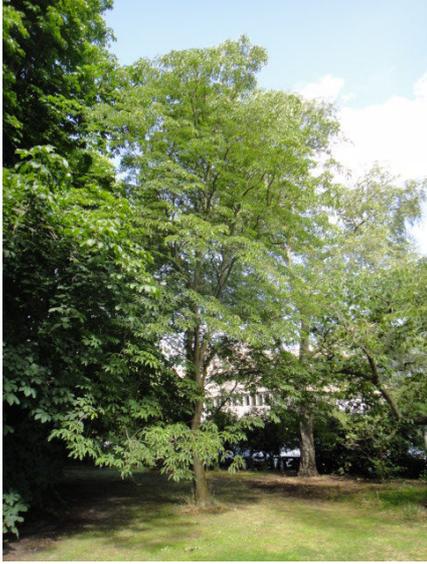
Tree Species:	Indian Horse Chestnut (<i>Aesculus indica</i>)	
Protection Status:	Nil	
Age Class:	Mature	
Height:	9.0m	
Canopy Spread:	8.0m	
DBH:	0.29m	
Health:	3 (Average)	
Form:	3 (Average)	
Overall Condition:	3 (Average)	
Comments:	Tree to be removed. Within new building footprint.

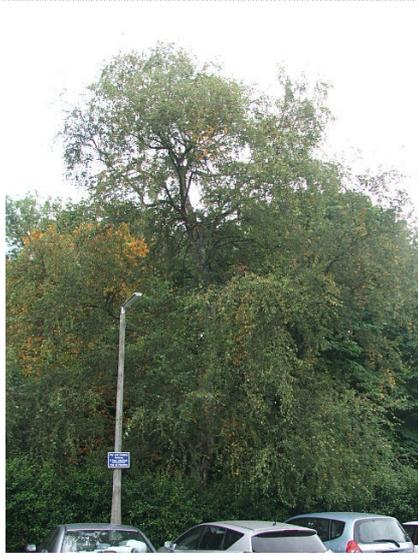
Tree Species:	Silver Birch <i>(Betula pendula)</i>	
Protection Status:	Nil	
Age Class:	Mature	
Height:	14.0m	
Canopy Spread:	12.0m	
DBH:	0.55m	
Health:	3 (Average)	
Form:	3 (Average)	
Overall Condition:	3 (Average)	
Comments:	Tree to be removed. Within new building footprint.

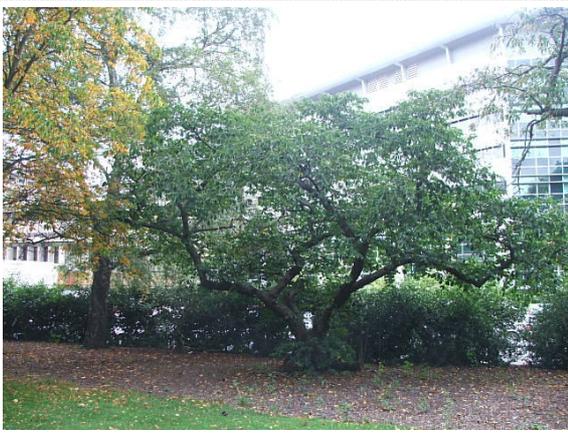
Tree Species:	Yoshino Cherry <i>(Prunus x Yedoensis)</i>	
Protection Status:	Nil	
Age Class:	Over-Mature	
Height:	6.0m	
Canopy Spread:	11.0m	
DBH:	0.62m	
Health:	3 (Average)	
Form:	3 (Average)	
Overall Condition:	3 (Average)	
Comments:	Tree to be removed. Within new building footprint.

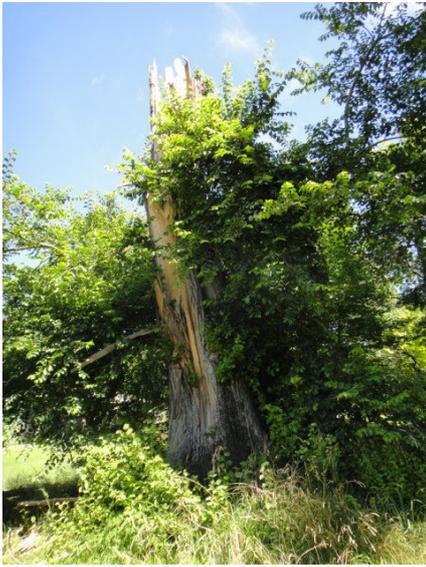
Tree Species:	English Elm (<i>Ulmus procera</i>)	
Protection Status:	Nil	
Age Class:	Mature	
Height:	N/A	
Canopy Spread:	N/A	
DBH:	N/A	
Health:	5 (Very-Poor)	
Form:	5 (Very-Poor)	
Overall Condition:	5 (Very-Poor)	
Comments:	Tree to be removed. Within new building footprint. Tree trunk failed structurally during recent high wind conditions.

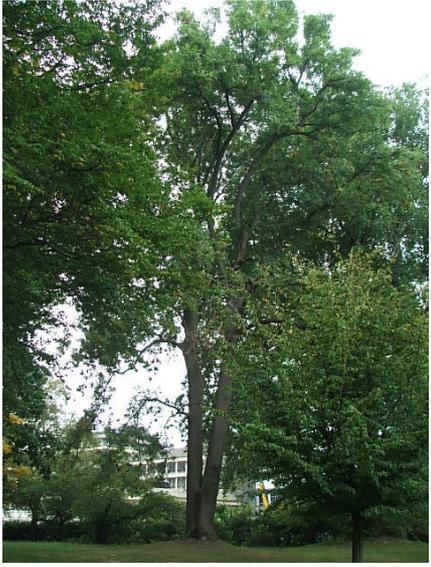
Tree Species:	English Ash (<i>Fraxinus excelsior</i>)	
Protection Status:	Nil	
Age Class:	Over-Mature	
Height:	24.0m	
Canopy Spread:	17.0m	
DBH:	1.06m	
Health:	3 (Average)	
Form:	3 (Average)	
Overall Condition:	3 (Average)	
Comments:	Tree to be removed. Within new building footprint.

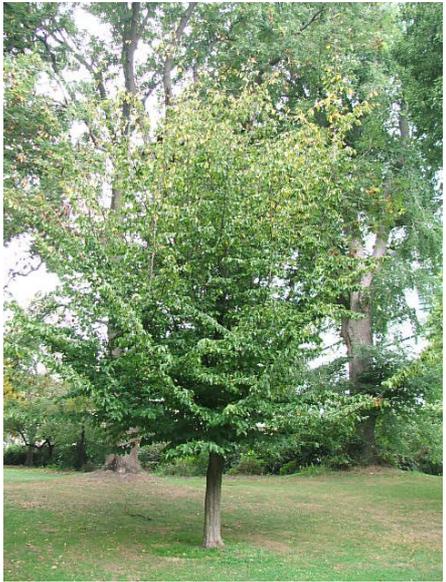
Tree Species:	Persian Ironwood (<i>Parrotia persica</i>)	
Protection Status:	Nil	
Age Class:	Mature	
Height:	7.0m	
Canopy Spread:	7.0m	
DBH:	0.26m	
Health:	2 (Good)	
Form:	3 (Average)	
Overall Condition:	3 (Average)	
Comments:	Tree to be removed. Within new building footprint.

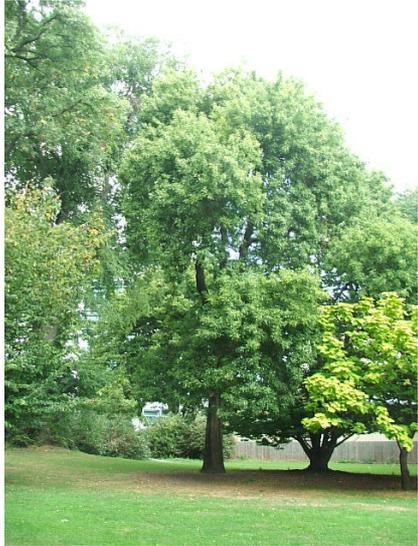
Tree Species:	Weeping Ash (<i>Fraxinus excelsior</i> Pendula)	
Protection Status:	Nil	
Age Class:	Over-Mature	
Height:	18.0m	
Canopy Spread:	11.0m	
DBH:	0.71m	
Health:	3 (Average)	
Form:	3 (Average)	
Overall Condition:	3 (Average)	
Comments:	Tree to be removed. Within new building footprint.

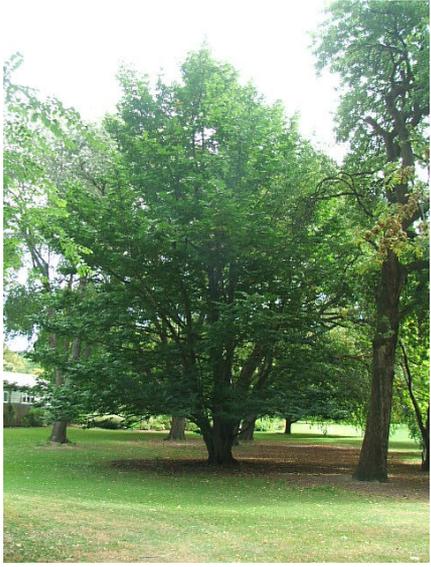
Tree Species:	Caucasian Wingnut (<i>Pterocarya fraxinifolia</i>)	
Protection Status:	Nil	
Age Class:	Mature	
Height:	15.0m	
Canopy Spread:	15.0m	
DBH:	0.85m	
Health:	2 (Good)	
Form:	3 (Average)	
Overall Condition:	3 (Average)	
Comments:	Tree to be removed. Within new building footprint.

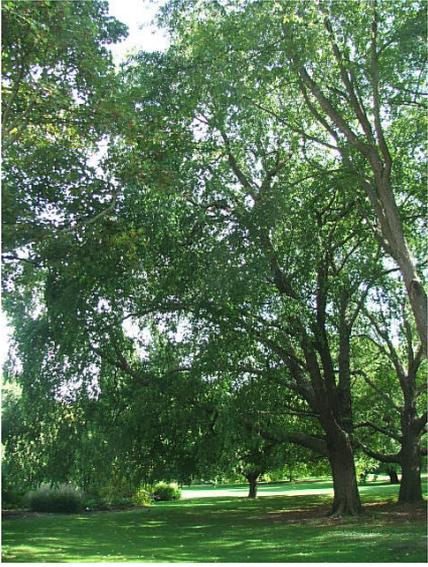
Tree Species:	River Birch (<i>Betula nigra</i>)	
Protection Status:	Nil	
Age Class:	Mature	
Height:	18.0m	
Canopy Spread:	20.0m	
DBH:	0.96m	
Health:	3 (Average)	
Form:	3 (Average)	
Overall Condition:	3 (Average)	
Comments:	Tree to be removed. Within new building footprint.

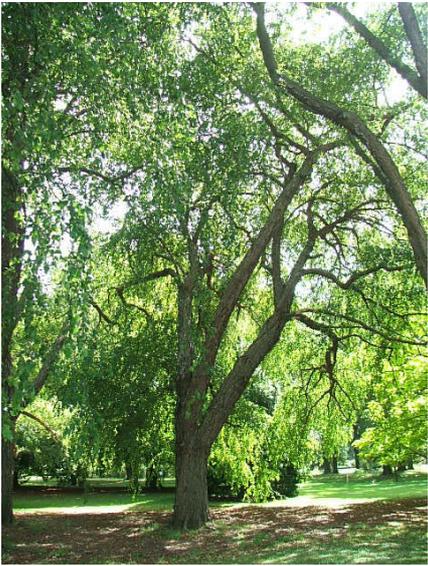
Tree Species:	River Birch (<i>Betula nigra</i>)	
Protection Status:	Nil	
Age Class:	Mature	
Height:	18.0m	
Canopy Spread:	18.0m	
DBH:	0.87m	
Health:	3 (Average)	
Form:	3 (Average)	
Overall Condition:	3 (Average)	
Comments:	Tree to be removed. Within new building footprint.

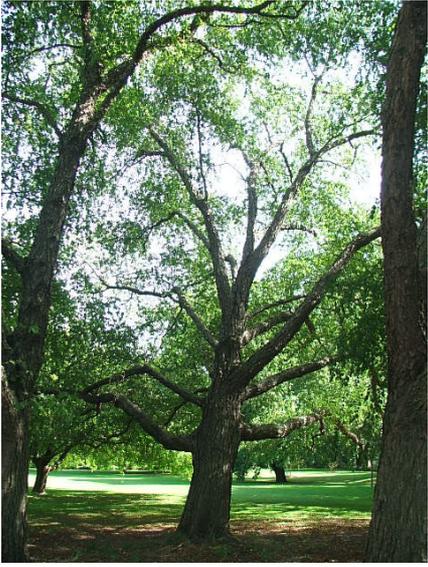
Tree Species:	River Birch (<i>Betula nigra</i>)	
Protection Status:	Nil	
Age Class:	Mature	
Height:	17.0m	
Canopy Spread:	16.0m	
DBH:	0.88m	
Health:	3 (Average)	
Form:	3 (Average)	
Overall Condition:	3 (Average)	
Comments:	Tree to be removed. Within new building footprint.

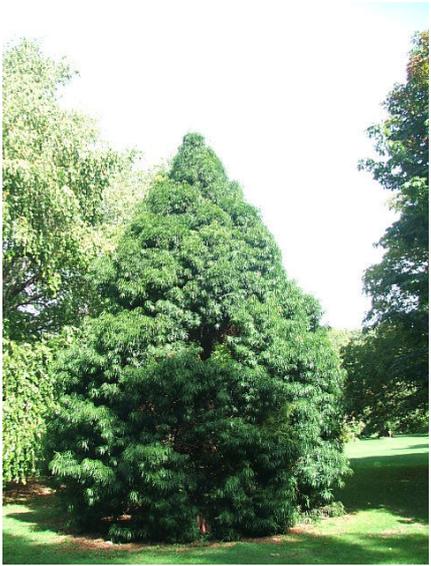
Tree Species:	Falcate Yellowwood (<i>Podocarpus henkelii</i>)	
Protection Status:	Nil	
Age Class:	Mature	
Height:	8.0m	
Canopy Spread:	8.0m	
DBH:	0.37m	
Health:	2 (Good)	
Form:	3 (Average)	
Overall Condition:	3 (Average)	
Comments:	Tree to be removed. Within new building footprint.

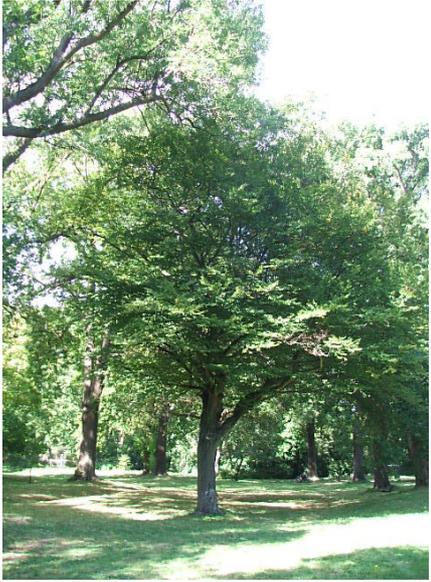
Tree Species:	Common Hornbeam <i>(Carpinus betulus)</i>	
Protection Status:	Nil	
Age Class:	Mature	
Height:	13.0m	
Canopy Spread:	13.0m	
DBH:	0.61m	
Health:	3 (Average)	
Form:	3 (Average)	
Overall Condition:	3 (Average)	
Comments:	Tree to be removed. Within new building footprint.

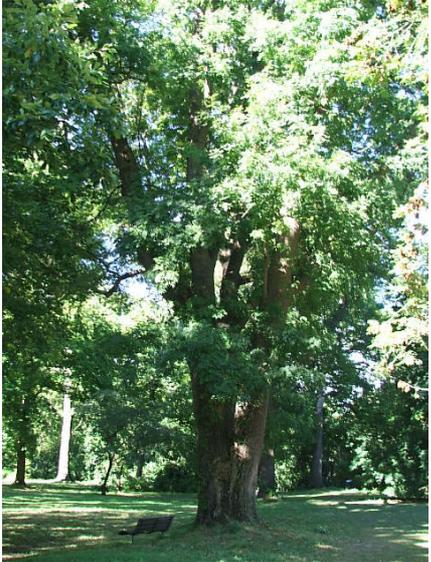
Tree Species:	English Ash <i>(Fraxinus excelsior)</i>	
Protection Status:	Nil	
Age Class:	Over-Mature	
Height:	25.0m	
Canopy Spread:	17.0m	
DBH:	1.34m	
Health:	3 (Average)	
Form:	3 (Average)	
Overall Condition:	3 (Average)	
Comments:	Tree to be removed. Within new building footprint.

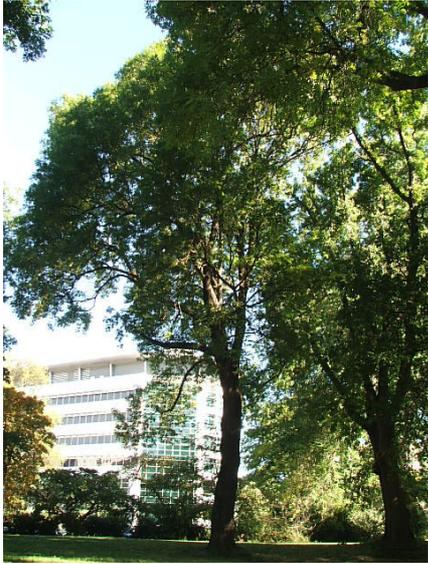
Tree Species:	English Ash <i>(Fraxinus excelsior)</i>	
Protection Status:	Nil	
Age Class:	Over-Mature	
Height:	25.0m	
Canopy Spread:	20.0m	
DBH:	1.01m	
Health:	3 (Average)	
Form:	3 (Average)	
Overall Condition:	3 (Average)	
Comments:	Tree to be removed. Within new building footprint.

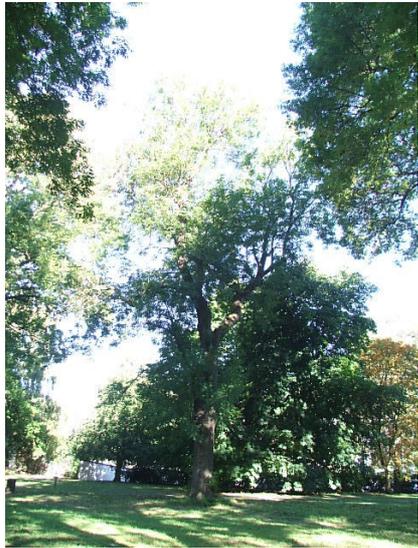
Tree Species:	English Ash <i>(Fraxinus excelsior)</i>	
Protection Status:	Nil	
Age Class:	Over-Mature	
Height:	23.0m	
Canopy Spread:	12.0m	
DBH:	0.95m	
Health:	3 (Average)	
Form:	4 (Poor)	
Overall Condition:	4 (Poor)	
Comments:	Tree to be removed. Within new building footprint.

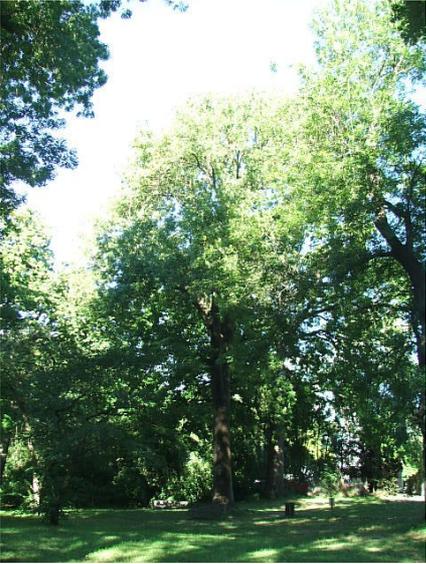
Tree Species:	English Ash (<i>Fraxinus excelsior</i>)	
Protection Status:	Nil	
Age Class:	Over-Mature	
Height:	25.0m	
Canopy Spread:	16.0m	
DBH:	1.0m	
Health:	3 (Average)	
Form:	3 (Average)	
Overall Condition:	3 (Average)	
Comments:	Tree to be removed. Within new building footprint.

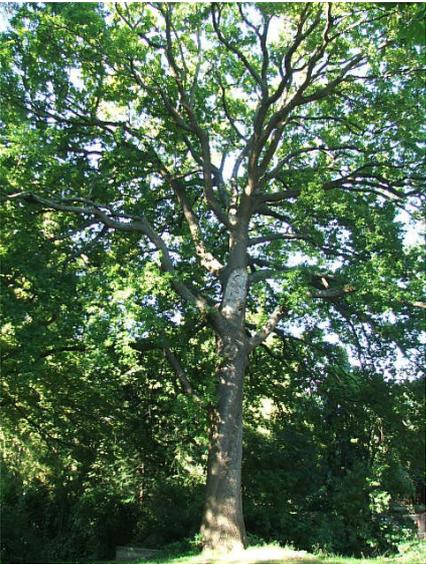
Tree Species:	English Oak (<i>Quercus robur</i>)	
Protection Status:	Nil	
Age Class:	Over-Mature	
Height:	24.0m	
Canopy Spread:	24.0m	
DBH:	1.3m	
Health:	3 (Average)	
Form:	4 (Poor)	
Overall Condition:	4 (Poor)	
Comments:	Tree to be removed. Within new building footprint.

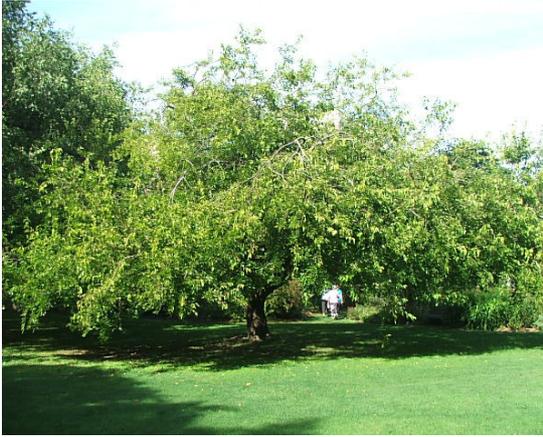
Tree Species:	White Mulberry (<i>Morus alba</i>)	
Protection Status:	CCC Asset	
Age Class:	Mature	
Height:	9.0m	
Canopy Spread:	14.0m	
DBH:	0.56m	
Health:	3 (Average)	
Form:	3 (Average)	
Overall Condition:	3 (Average)	
Comments:	Retain and protect during construction works. Tree within vicinity of new boundary, and may require minor lateral boundary reduction pruning to provide adequate clearance.

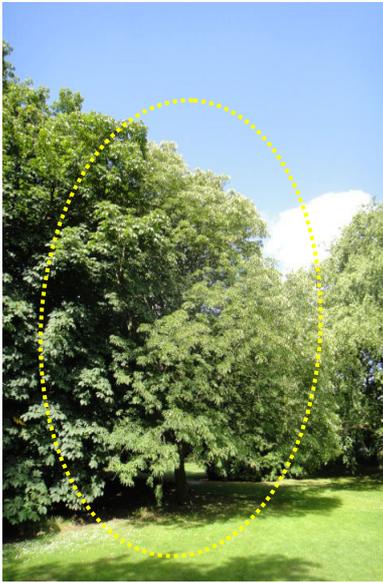
Tree Species:	Sweet Buckeye (<i>Aesculus flava</i>)	
Protection Status:	CCC Asset	
Age Class:	Mature	
Height:	11.0m	
Canopy Spread:	10.0m	
DBH:	0.41m	
Health:	3 (Average)	
Form:	3 (Average)	
Overall Condition:	3 (Average)	
Comments:	Tree to be removed. Tree base within 2.0 metres of boundary line.

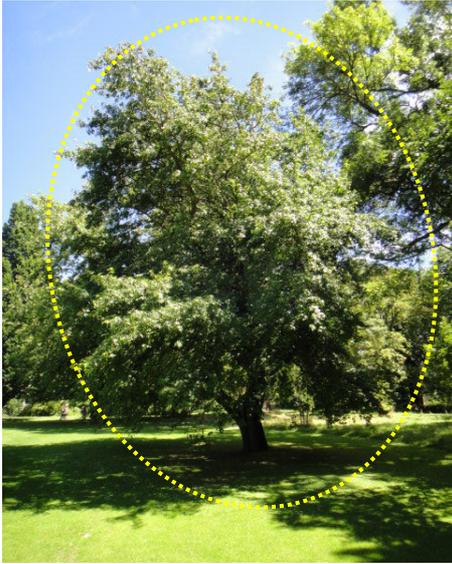
Tree Species:	Sweetgum (<i>Liquidambar styraciflua</i> Worpleston)	
Protection Status:	CCC Asset	
Age Class:	Over-Mature	
Height:	12.0m	
Canopy Spread:	16.0m	
DBH:	0.85m	
Health:	3 (Average)	
Form:	3 (Average)	
Overall Condition:	3 (Average)	
Comments:	<p>Retain and protect during construction works.</p> <p>Tree within vicinity of new boundary.</p> <p>Tree has an old stem failure wound at 1.5 metres above ground, and decay in trunk and branch structure. Two historic cable braces in mid canopy. Tree may be prone to structural failures.</p>

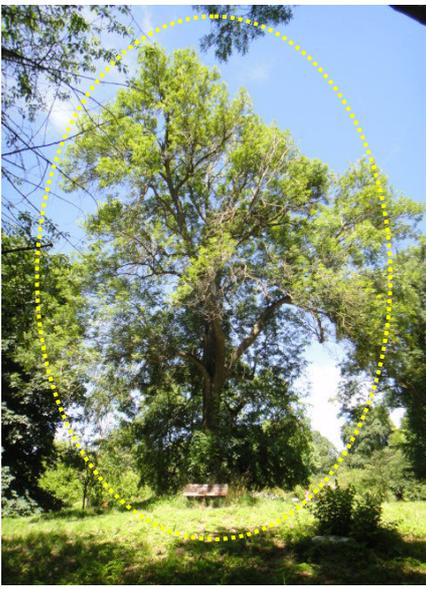
Tree Species:	English Ash (<i>Fraxinus excelsior</i>)	
Protection Status:	CCC Asset	
Age Class:	Over-Mature	
Height:	25.0m	
Canopy Spread:	18.0m	
DBH:	0.9m	
Health:	3 (Average)	
Form:	3 (Average)	
Overall Condition:	3 (Average)	
Comments:	<p>Tree should be removed due to change in park use.</p> <p>Tree within vicinity of new boundary.</p> <p>Tree has decay in trunk and branch structure, and may be prone to structural failures within vicinity of new building.</p>

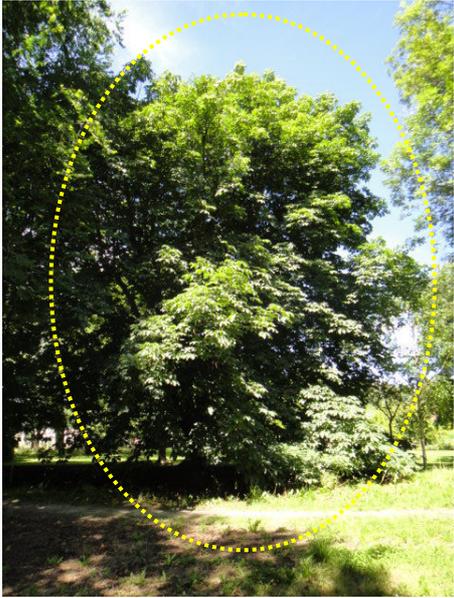
Tree Species:	Baumann's Horse Chestnut (<i>Aesculus hippocastanum Baumannii</i>)	
Protection Status:	CCC Asset	
Age Class:	Mature	
Height:	18.0m	
Canopy Spread:	14.0m	
DBH:	0.5m	
Health:	3 (Average)	
Form:	3 (Average)	
Overall Condition:	3 (Average)	
Comments:	<p>Retain and protect during construction works (if possible). Tree within near vicinity of new boundary. It may be possible to retain this tree during development. The canopy extends approximately 2.0 metres over the new boundary line, and boundary reduction pruning will be required.</p>

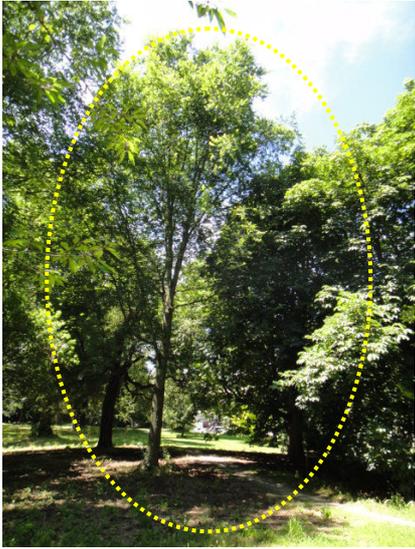
Tree Species:	English Elm (<i>Ulmus procera</i>)	
Protection Status:	CCC Asset	
Age Class:	Mature	
Height:	18.0m	
Canopy Spread:	14.0m	
DBH:	0.5m	
Health:	3 (Average)	
Form:	3 (Average)	
Overall Condition:	3 (Average)	
Comments:	<p>Tree should be removed due to change in park use. Tree within vicinity of new boundary. Ongoing conflicts between the tree and new building are likely to occur as the tree develops and matures within the vicinity of the building.</p>

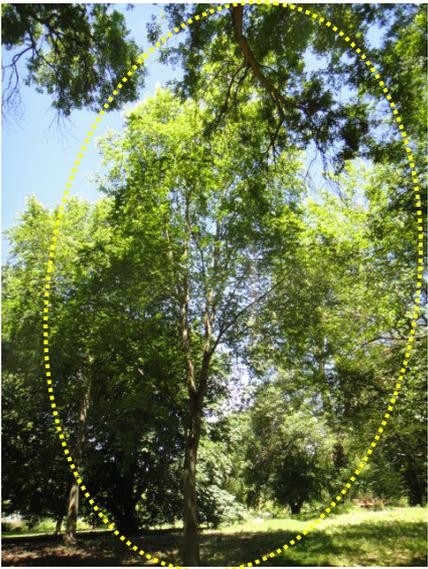
Tree Species:	English Elm (<i>Ulmus procera</i>)	
Protection Status:	CCC Asset	
Age Class:	Mature	
Height:	18.0m	
Canopy Spread:	13.0m	
DBH:	0.45m	
Health:	3 (Average)	
Form:	4 (Poor)	
Overall Condition:	4 (Poor)	
Comments:	<p>Tree should be removed due to change in park use.</p> <p>This tree was found to have a failed (included) stem union, and should be removed.</p>

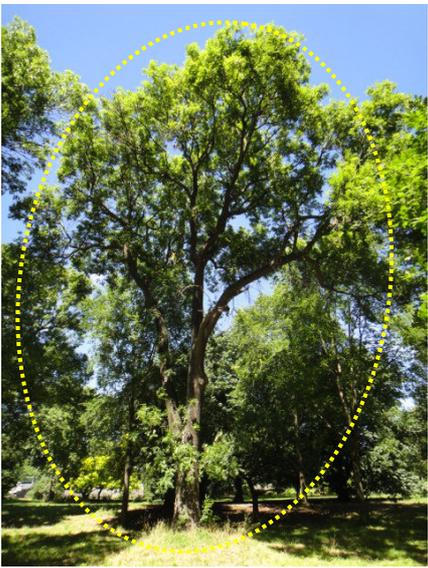
Tree Species:	English Ash (<i>Fraxinus excelsior</i>)	
Protection Status:	CCC Asset	
Age Class:	Over-Mature	
Height:	25.0m	
Canopy Spread:	25.0m	
DBH:	1.0m	
Health:	3 (Average)	
Form:	3 (Average)	
Overall Condition:	3 (Average)	
Comments:	<p>Tree should be removed due to change in park use.</p> <p>Although not within the immediate vicinity of the new building, the tree has decay in trunk and branch structure and may be prone to structural failures following changes to the site.</p> <p>There is an open area within the vicinity of this tree that would be suitable for replacement trees to be planted.</p>

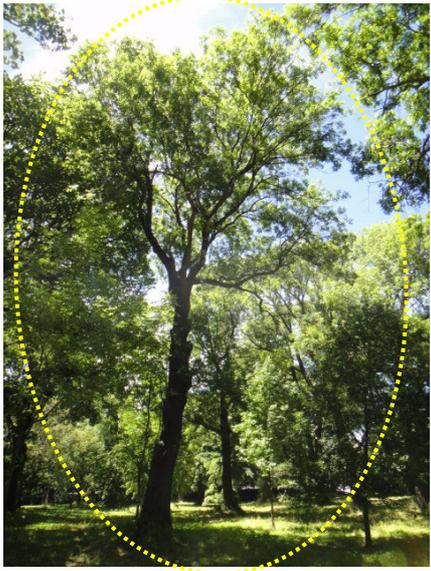
Tree Species:	English Ash (<i>Fraxinus excelsior</i>)	
Protection Status:	CCC Asset	
Age Class:	Over-Mature	
Height:	25.0m	
Canopy Spread:	21.0m	
DBH:	1.1m	
Health:	3 (Average)	
Form:	3 (Average)	
Overall Condition:	3 (Average)	
Comments:	<p>Tree should be removed due to change in park use.</p> <p>Although not within the immediate vicinity of the new building, the tree has decay in trunk and branch structure and may be prone to structural failures following changes to the site.</p> <p>There are three semi-mature emerging trees within the vicinity of the subject tree that would eventually assist with mitigating the loss in tree cover.</p>

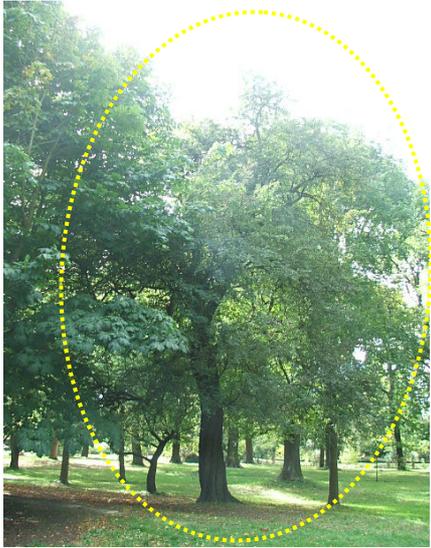
Tree Species:	Double White Hawthorn (<i>Crataegus laevigatus</i> Plena)	
Protection Status:	CCC Asset	
Age Class:	Over-Mature	
Height:	18.0m	
Canopy Spread:	12.0m	
DBH:	0.74m	
Health:	3 (Average)	
Form:	4 (Poor)	
Overall Condition:	4 (Poor)	
Comments:	<p>Tree should be removed.</p> <p>Tree located within vicinity of new boundary line, and would require significant pruning if retained.</p> <p>Tree has extensive decay and structural decline.</p>

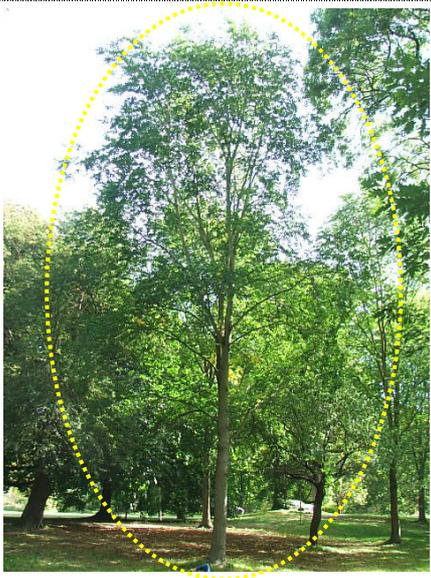
Tree Species:	English Elm (<i>Ulmus procera</i>)	
Protection Status:	CCC Asset	
Age Class:	Mature	
Height:	19.0m	
Canopy Spread:	7.0m	
DBH:	0.37m	
Health:	3 (Average)	
Form:	3 (Average)	
Overall Condition:	3 (Average)	
Comments:	<p>Retain and protect during construction works.</p> <p>Tree is near the new boundary, but is in reasonably good condition and should be retained.</p>

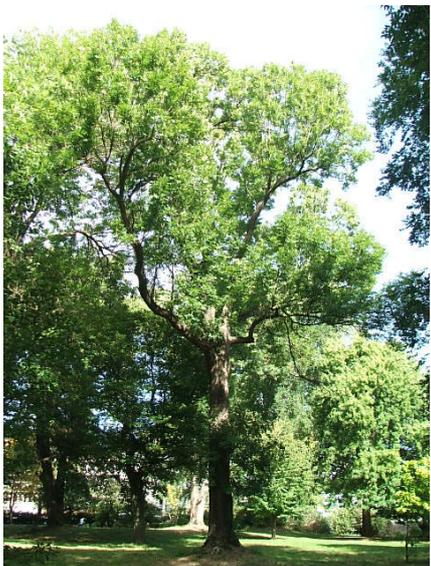
Tree Species:	English Elm (<i>Ulmus procera</i>)	
Protection Status:	CCC Asset	
Age Class:	Over-Mature	
Height:	25.0m	
Canopy Spread:	18.0m	
DBH:	1.0m	
Health:	3 (Average)	
Form:	3 (Average)	
Overall Condition:	3 (Average)	
Comments:	<p>Tree should be removed.</p> <p>Tree located within near vicinity of new boundary line, and would require significant pruning if retained.</p> <p>The root system of the tree is also likely to be compromised during the construction works.</p>

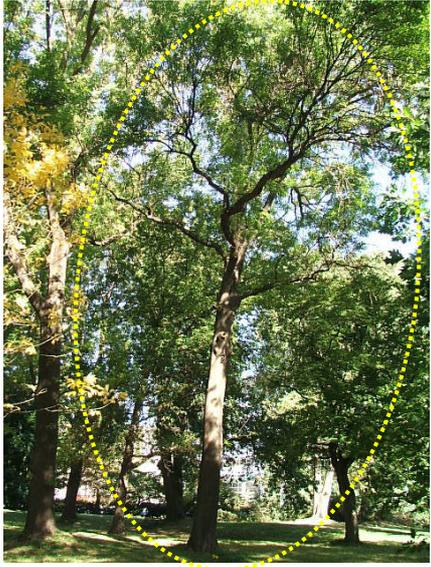
Tree Species:	English Ash <i>(Fraxinus excelsior)</i>	
Protection Status:	CCC Asset	
Age Class:	Over-Mature	
Height:	25.0m	
Canopy Spread:	18.0m	
DBH:	0.86m	
Health:	3 (Average)	
Form:	3 (Average)	
Overall Condition:	3 (Average)	
Comments:	<p>Tree should be removed due to change in park use.</p> <p>The canopy of this tree extends over the new boundary line.</p> <p>There is decay in the trunk and branch structure, and the tree may be prone to structural failures following changes to the site.</p>

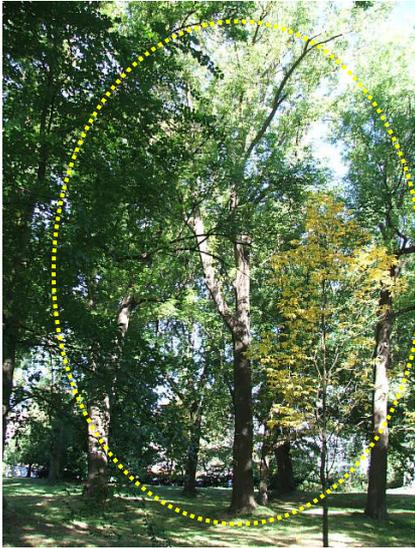
Tree Species:	English Ash <i>(Fraxinus excelsior)</i>	
Protection Status:	CCC Asset	
Age Class:	Over-Mature	
Height:	23.0m	
Canopy Spread:	18.0m	
DBH:	1.0m	
Health:	3 (Average)	
Form:	3 (Average)	
Overall Condition:	3 (Average)	
Comments:	<p>Tree should be removed due to change in park use.</p> <p>The tree will be within the vicinity of the new building, and has decay in the trunk and branch structure and may be prone to structural failures following changes to the site.</p>

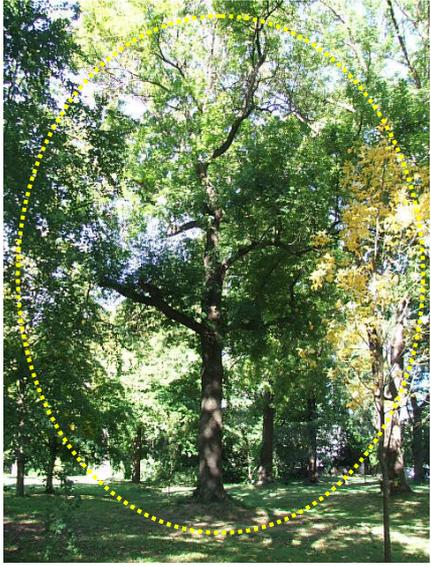
Tree Species:	English Ash (<i>Fraxinus excelsior</i>)	
Protection Status:	CCC Asset	
Age Class:	Over-Mature	
Height:	23.0m	
Canopy Spread:	17.0m	
DBH:	0.92m	
Health:	3 (Average)	
Form:	3 (Average)	
Overall Condition:	3 (Average)	
Comments:	<p>Tree should be removed due to change in park use.</p> <p>Although not within the immediate vicinity of the new building, the tree has been partially suppressed by tree ID 106480, with decay in the trunk and branch structure and may be prone to structural failures following changes to the site.</p>

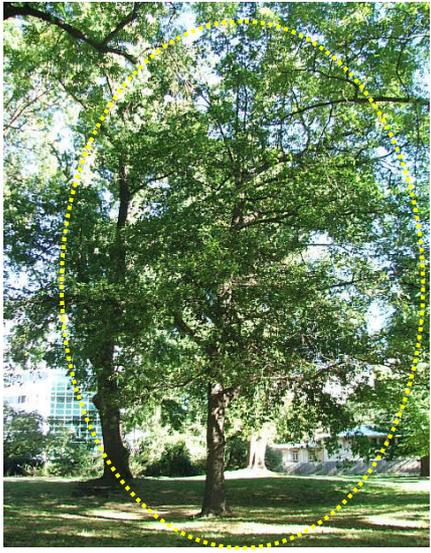
Tree Species:	Oak (<i>Quercus sp.</i>)	
Protection Status:	CCC Asset	
Age Class:	Mature	
Height:	19.0m	
Canopy Spread:	17.0m	
DBH:	0.58m	
Health:	3 (Average)	
Form:	3 (Average)	
Overall Condition:	3 (Average)	
Comments:	<p>Tree to be removed.</p> <p>Within immediate vicinity of the new boundary line and building.</p>

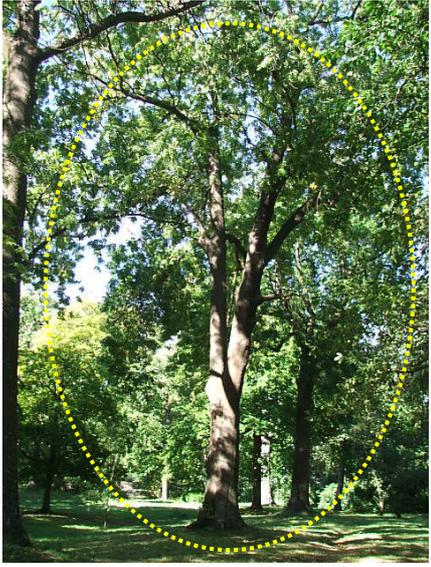
Tree Species:	English Ash <i>(Fraxinus excelsior)</i>	
Protection Status:	CCC Asset	
Age Class:	Over-Mature	
Height:	25.0m	
Canopy Spread:	23.0m	
DBH:	1.16m	
Health:	3 (Average)	
Form:	3 (Average)	
Overall Condition:	3 (Average)	
Comments:	<p>Tree should be removed due to change in park use.</p> <p>The canopy of this tree extends over the new boundary line.</p> <p>There is decay in the trunk and branch structure, and the tree may be prone to structural failures following changes to the site.</p>

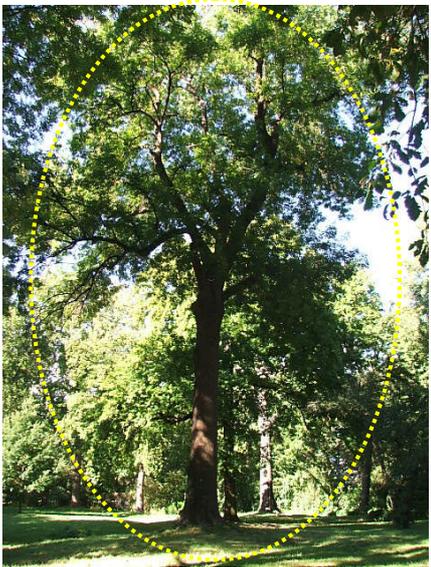
Tree Species:	English Ash <i>(Fraxinus excelsior)</i>	
Protection Status:	CCC Asset	
Age Class:	Over-Mature	
Height:	24.0m	
Canopy Spread:	17.0m	
DBH:	1.15m	
Health:	3 (Average)	
Form:	3 (Average)	
Overall Condition:	3 (Average)	
Comments:	<p>Tree should be removed due to change in park use.</p> <p>The canopy of this tree extends over the new boundary line.</p> <p>There is decay in the trunk and branch structure, and the tree may be prone to structural failures following changes to the site.</p>

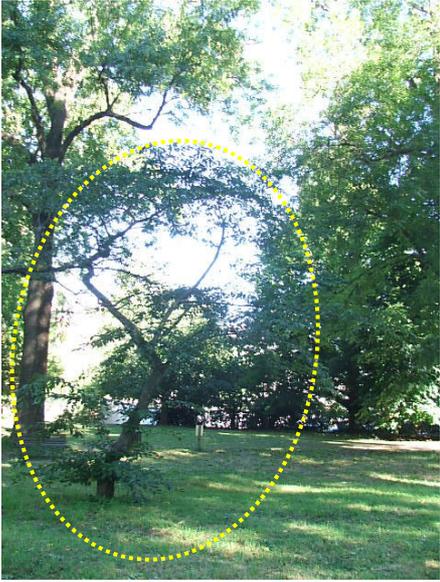
Tree Species:	Yoshino Cherry (<i>Prunus x Yedoensis</i>)	
Protection Status:	CCC Asset	
Age Class:	Over-Mature	
Height:	7.0m	
Canopy Spread:	8.0m	
DBH:	0.26m	
Health:	4 (Poor)	
Form:	4 (Poor)	
Overall Condition:	4 (Poor)	
Comments:	Tree to be removed. Within immediate vicinity of the new boundary line and building. Tree in poor condition.

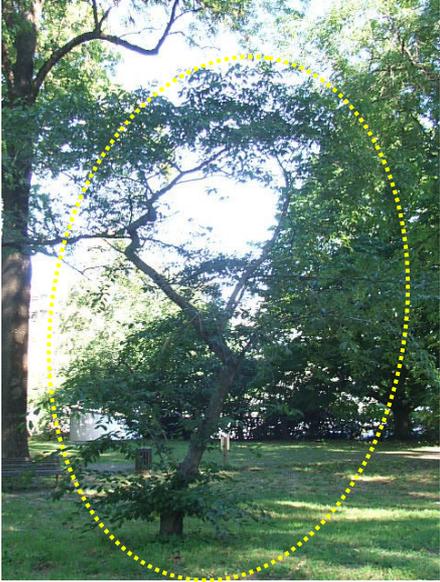
Tree Species:	Yoshino Cherry (<i>Prunus x Yedoensis</i>)	
Protection Status:	CCC Asset	
Age Class:	Over-Mature	
Height:	8.0m	
Canopy Spread:	8.0m	
DBH:	0.26m	
Health:	4 (Poor)	
Form:	3 (Average)	
Overall Condition:	4 (Poor)	
Comments:	Tree to be removed. Within immediate vicinity of the new boundary line and building. Tree in poor condition.

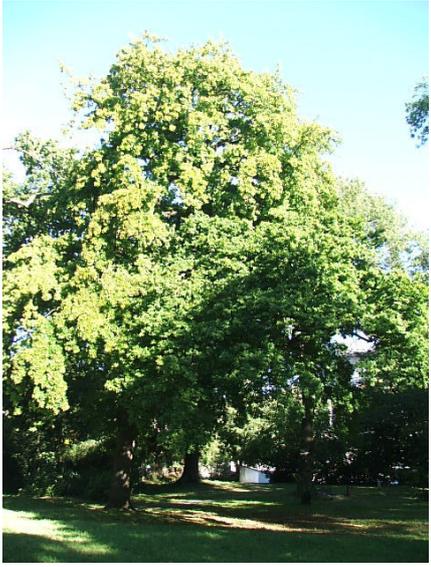
Tree Species:	English Oak (<i>Quercus robur</i>)	
Protection Status:	CCC Asset	
Age Class:	Over-Mature	
Height:	21.0m	
Canopy Spread:	20.0m	
DBH:	0.81m	
Health:	2 (Good)	
Form:	3 (Average)	
Overall Condition:	3 (Average)	
Comments:	Retain and protect during construction works.

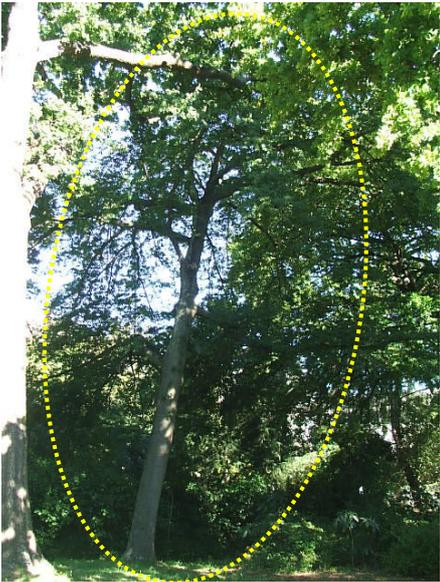
Tree Species:	Turkey Oak (<i>Quercus cerris</i>)	
Protection Status:	CCC Asset	
Age Class:	Over-Mature	
Height:	20.0m	
Canopy Spread:	18.0m	
DBH:	0.75m	
Health:	3 (Average)	
Form:	3 (Average)	
Overall Condition:	3 (Average)	
Comments:	<p>Tree should be removed due to change in park use.</p> <p>The base of the tree is approximately 7.0 metres from the new boundary line, and the tree would require extensive clearance pruning if retained.</p> <p>Also, the tree lean and canopy weight is towards the boundary.</p>

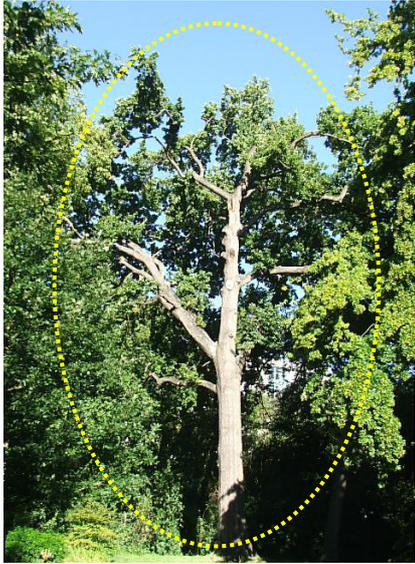
Tree Species:	English Oak (<i>Quercus robur</i>)	
Protection Status:	CCC Asset	
Age Class:	Over-Mature	
Height:	23.0m	
Canopy Spread:	18.0m	
DBH:	1.25m	
Health:	3 (Average)	
Form:	4 (Poor)	
Overall Condition:	4 (Poor)	
Comments:	<p>Tree should be removed due to change in park use.</p> <p>Although not within the immediate vicinity of the new building, the tree has had multiple previous structural failures and further failures are likely.</p>
