Area-wide geotechnical information summary for CERA zoning review panel

Table 1 – Area-wide geotechnical and engineering considerations for East Burwood

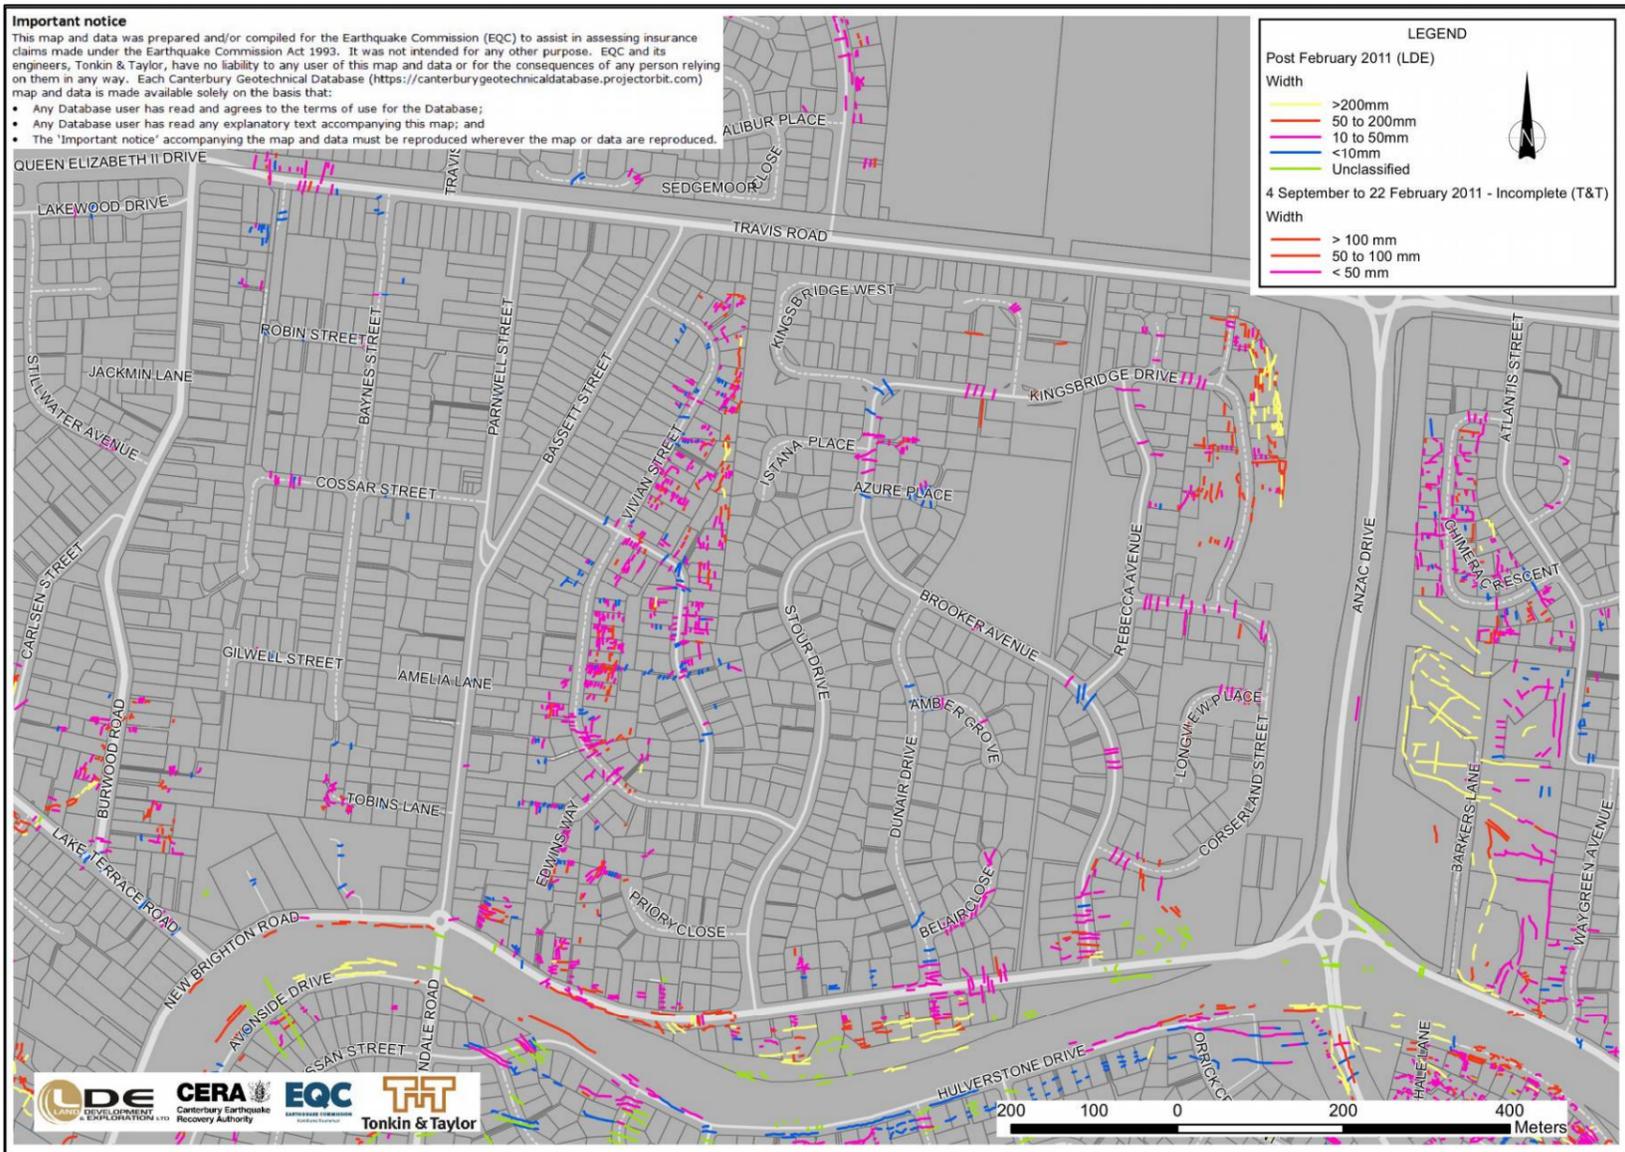
Figure 2 – Observed ground crack locations

Crack locations were mapped in order to infer the general direction, magnitude and extent of the lateral ground movements. The mapping objectives changed in response to the varying situation following the two earthquakes. Observations after the 4 Sept 2010 Earthquake were principally for insurance claim settlements. The crack widths were recorded in property-by-property observations, but cracks were not tracked across property boundaries and only a portion of properties were mapped before the 22 Feb 2011 Earthquake. Cracks were mapped at a scale of 1:5000 to 1:10000 for about two weeks following the 22 Feb 2011 Earthquake in order to rapidly identify the extent of lateral spreading following the earthquake. The individual crack widths were not recorded. From early March 2011, cracks were generally mapped at a scale of 1:2000 and classified according to their maximum width. Cracks were tracked through properties in order to identify regional patterns.

The crack mapping is incomplete and only observations made by the mapping teams are presented. In particular, the mapping following the 4 Sept 2010 Earthquake was incomplete before the 22 Feb 2011 Earthquake occurred and subsequent mapping remains incomplete within the residential 'red zone' areas. Also, cracks in roads were often not able to be mapped because many were filled and the roads resealed before a mapping team arrived.

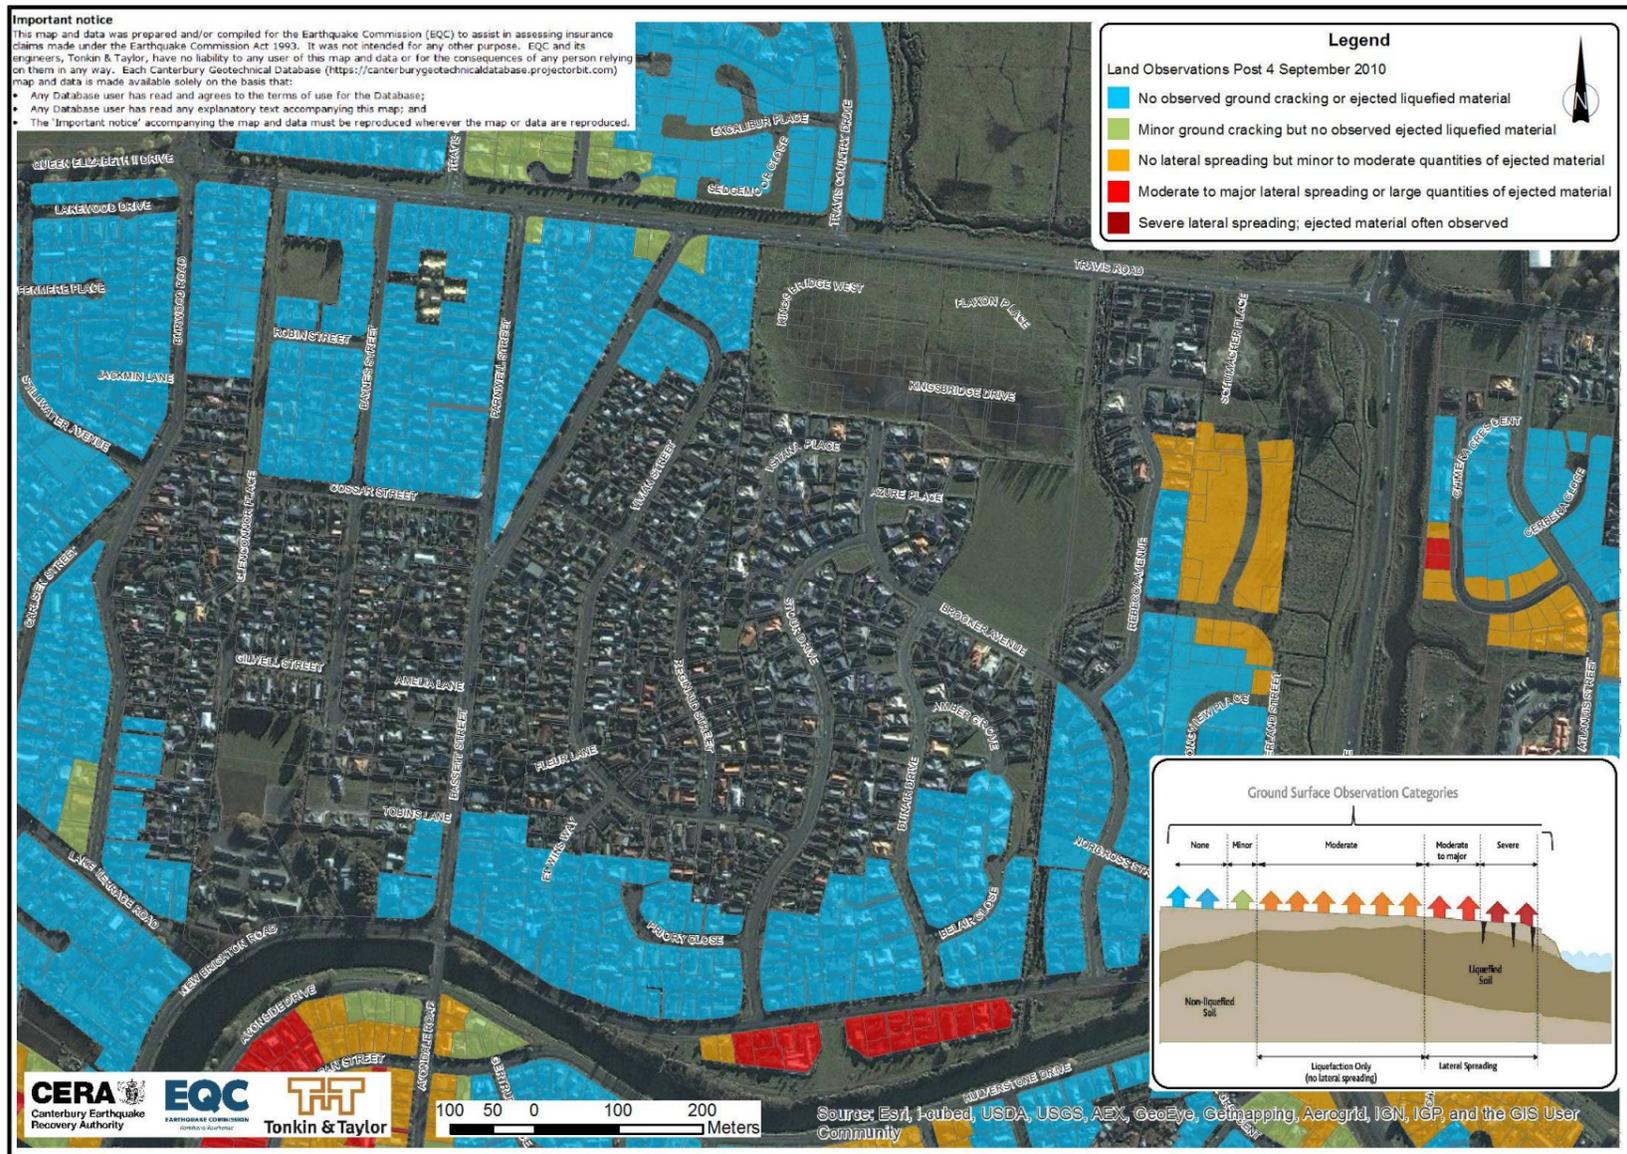
Figure 3 – Ground surface observations of liquefaction and lateral spreading following 4th September 2010 earthquake (from property-level ground mapping)

The quantities of material ejected due to liquefaction and observations of lateral spreading were collated from on-foot rapid inspection of individual properties following each significant earthquake. The observations were categorized according to the quantity of ejected material observed on the ground surface and according to the presence or absence of evidence of lateral spreading. Each of these three categories was further subdivided according to the severity. The colour coding used on these maps has completely different meaning to colours used by CERA for land zoning and DBH for technical categories.

The observations were collected for the Earthquake Commission and were only made in residential areas. The mapping only identified liquefaction and lateral spreading that was visible at the surface at the time of inspection. Liquefaction may have occurred at depth without obvious evidence at the surface and evidence of liquefaction may have been removed before the inspection. (Removed material may be identifiable within the aerial photographs that were taken within a day or two of the earthquake.)

The properties were not all inspected between each pair of consecutive earthquakes (e.g. between 4 Sept 2010 and 22 Feb 2011) so the extent of the land deformations is most likely incomplete. Also, some observations following the 22 Feb 2011 and 13 Jun 2011 earthquakes could have been induced by preceding earthquakes.

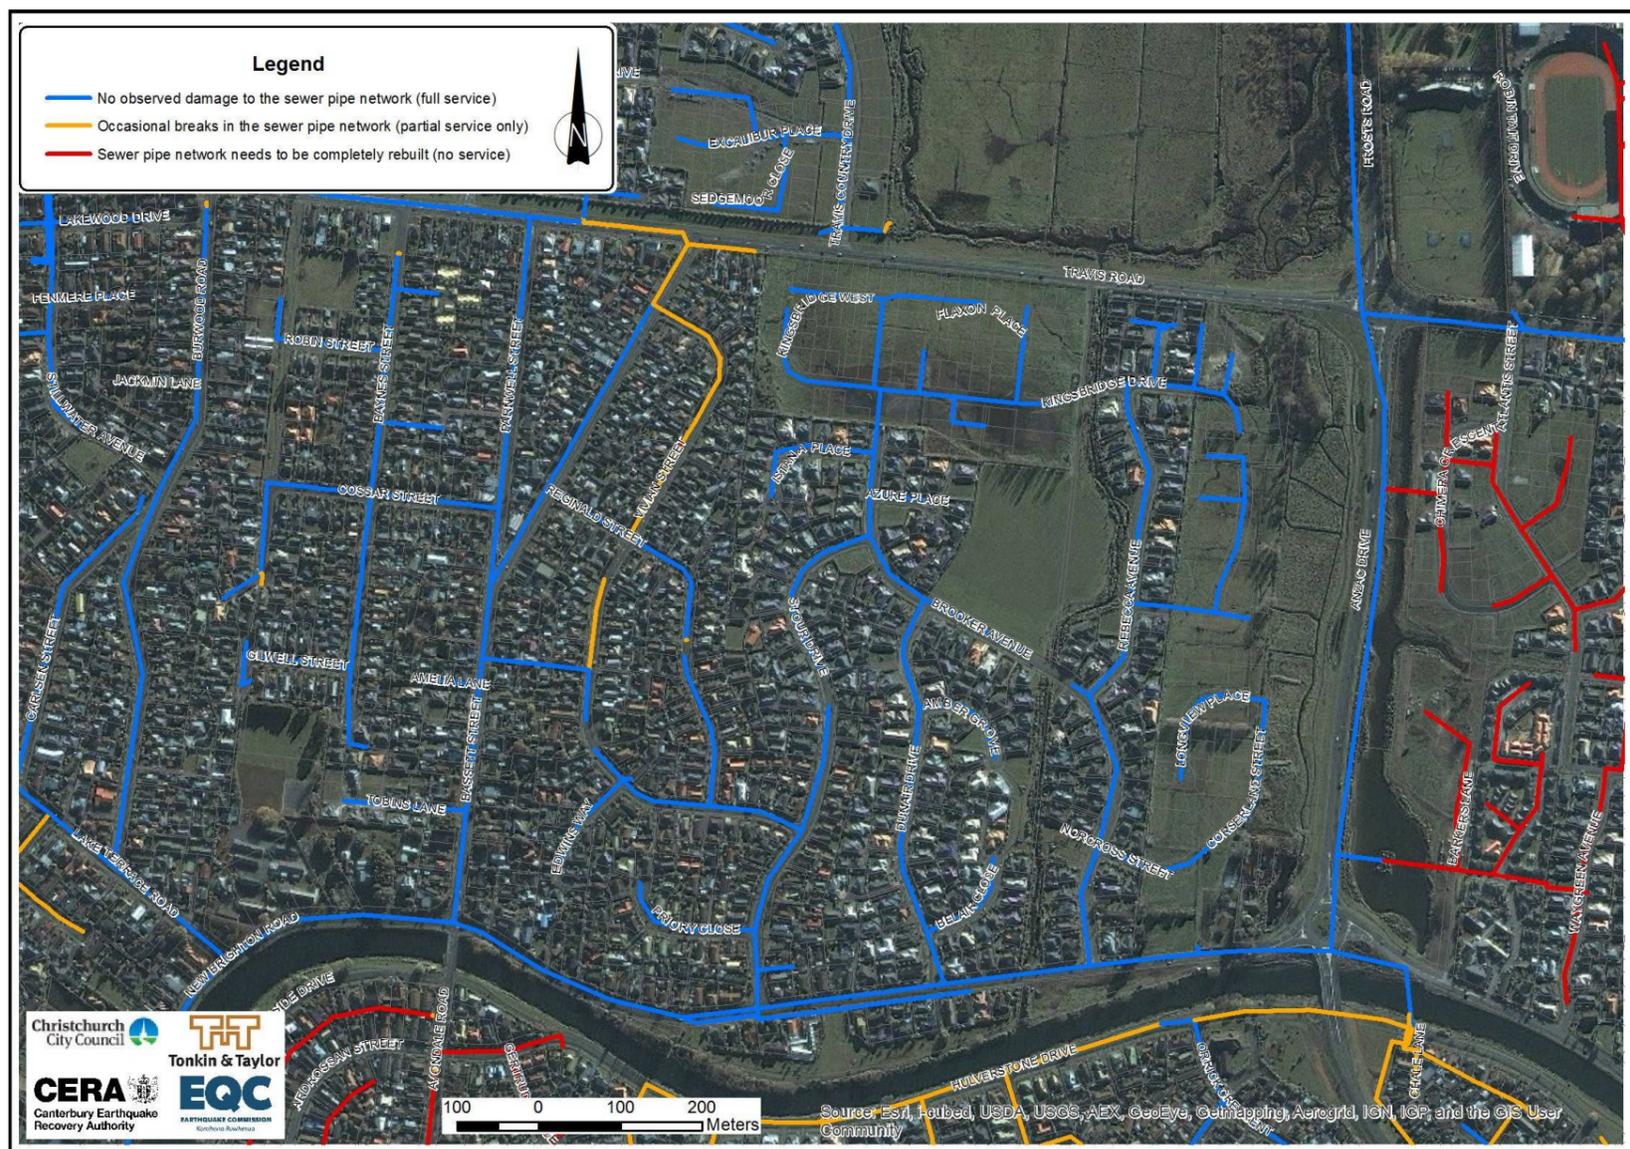
Figure 6 – Status of wastewater network as assessed at 20th April 2011 (NOW SUPERSEDED)

Since this map was compiled there has been significant additional assessment of the infrastructure network, so this map is now superseded. It is included only to show the best available information at the time of the zoning decisions. For an up to date assessment of the infrastructure network, SCIRT or the City Council should be consulted.

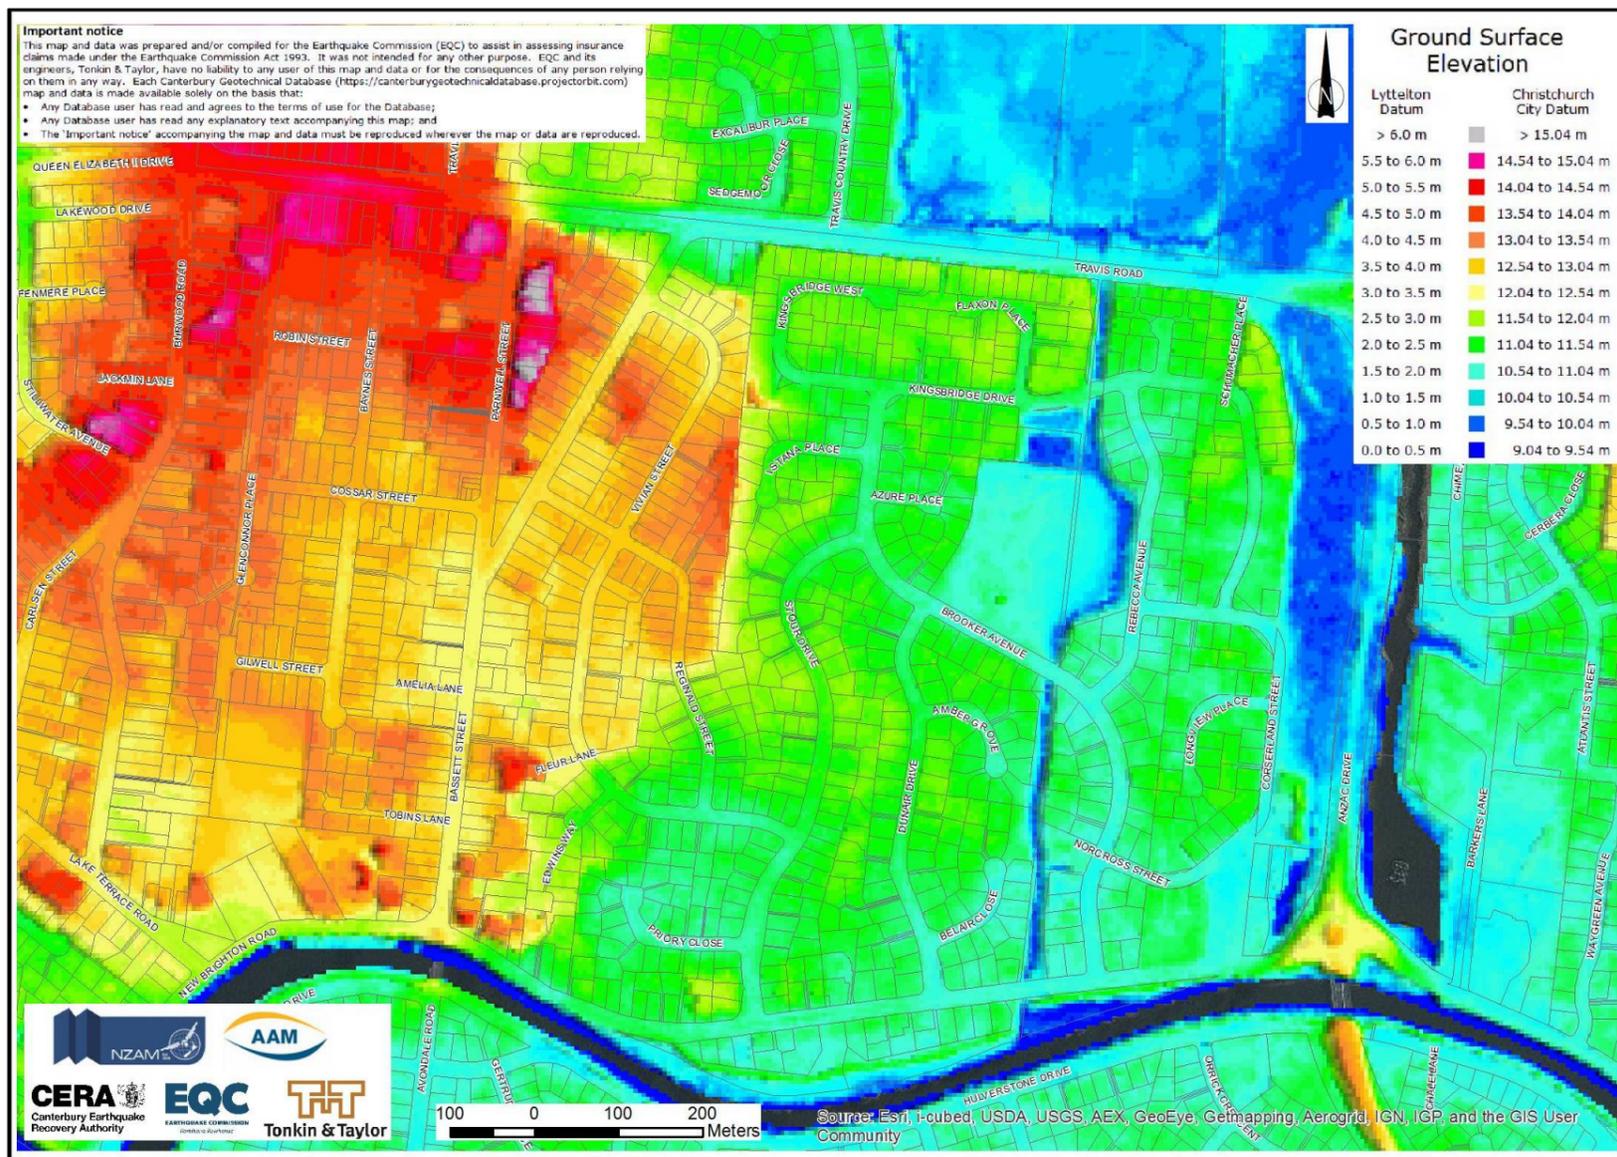
Figure 7 – Ground surface elevation from February 2012 LiDAR survey

LiDAR was acquired following each of the significant earthquakes. A digital elevation model was developed from each supplied LiDAR set by averaging the ground-return elevations within a 10 m radius of each grid point. Metadata supplied with the source LiDAR indicates a vertical accuracy of ± 0.07 to ± 0.15 m (excluding GPS error and Geoid modelling error) and 0.40 to 0.55 m horizontal. The pre-earthquake LiDAR has lower accuracy and sparser LiDAR point sets than the post-earthquake sets.

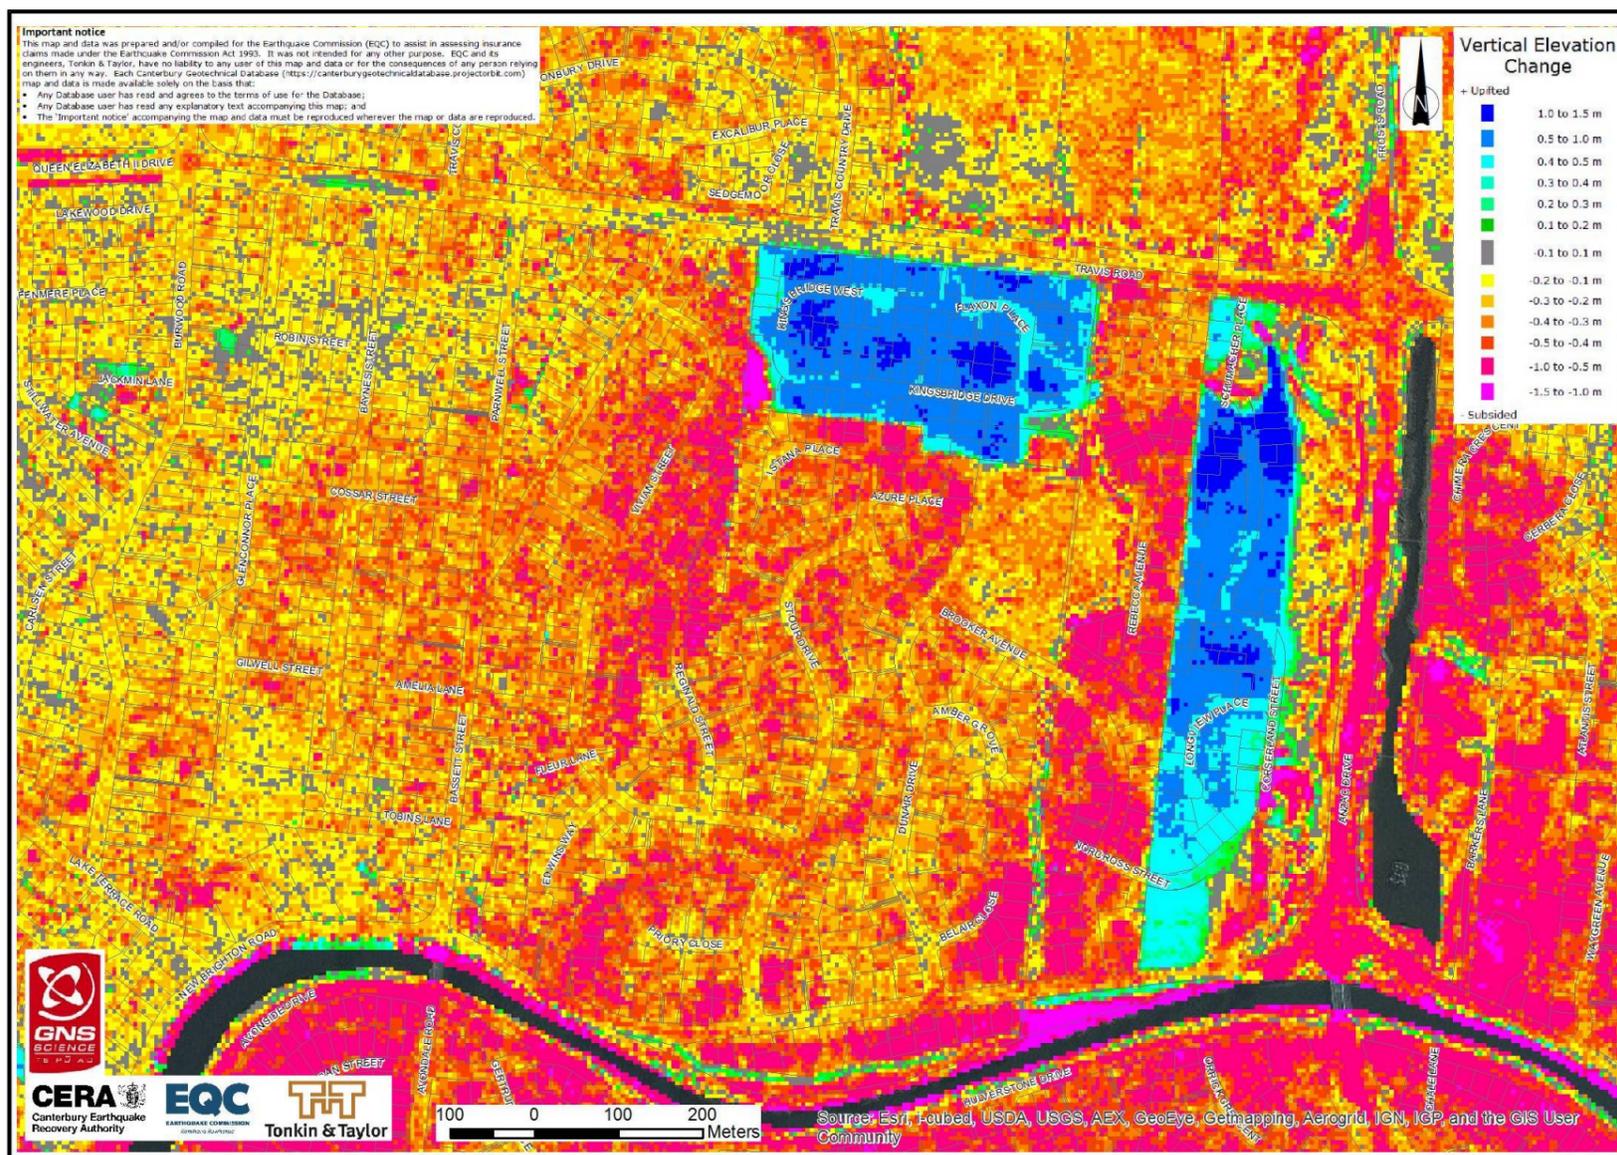
Figure 8 – Change in ground elevation between LiDAR in July 2003 and February 2012, with regional tectonic component of ground displacement removed

The areas coloured as blue above are where fill was placed as part of subdivision development after the first LiDAR survey was undertaken in 2003.

Vertical elevation changes between LiDAR sets that approximate the vertical ground movements during significant earthquakes. Elevation changes were calculated as differences between pairs of Digital Elevation Models (DEM). Local vertical movements were calculated as the differences between the 'observed' elevation differences and the regional tectonic displacement from GNS Science dislocation models of the vertical tectonic movements during each earthquake.

All of the movements are differences between DEMs and are inherently less accurate than their source DEM's. The pre-earthquake source DEM is less accurate than the post-earthquake DEMs. Some of the DEMs have visually distinguishable lines or ripples within the colour bands that are almost certainly artefacts from the data acquisition and subsequent processing rather than from physical vertical movements. Notable examples are several approximately NNE-SSW swathes visible in the Feb 2011 difference set and an almost E-W line at 43.48°S in the 13 Jun 2011 difference set.
