## Area-wide geotechnical information summary for CERA zoning review panel

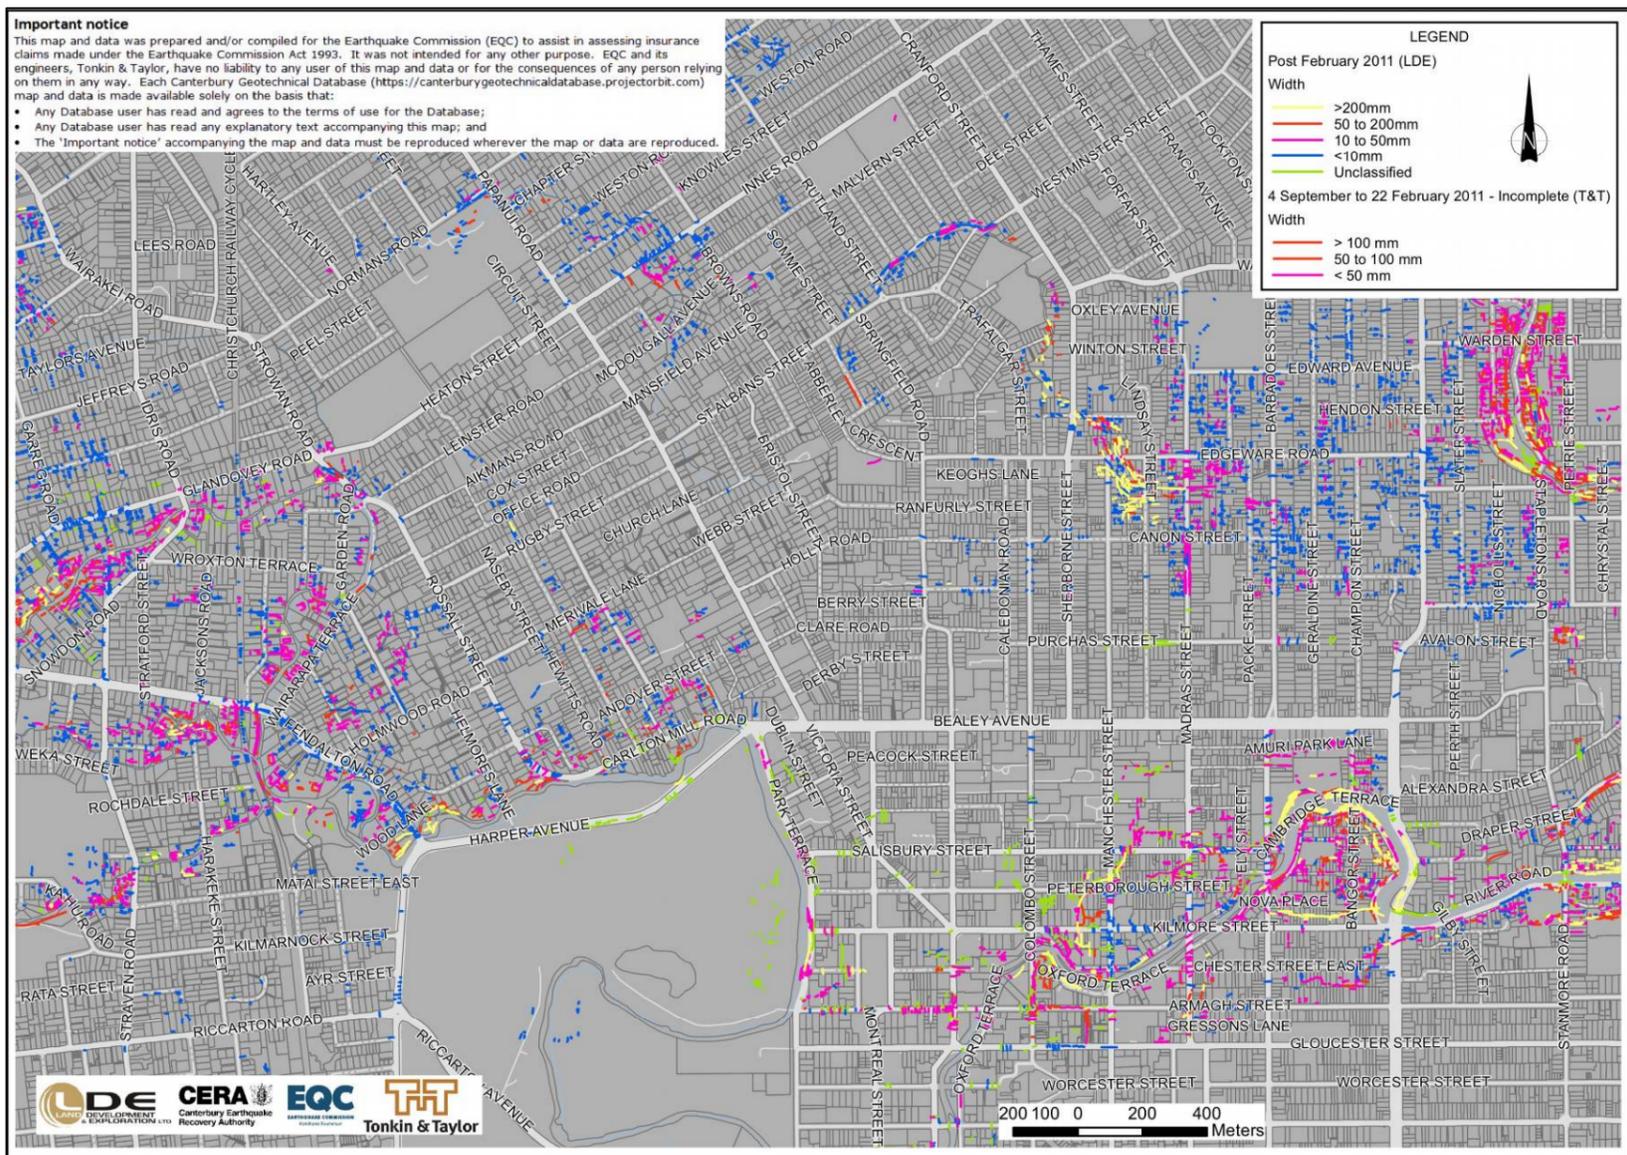
Figure 2 – Observed ground crack locations

**Fig 2** Canterbury Geotechnical Database (2012) "*Observed Ground Crack Locations*", Map Layer CGD0400 - 23 May 2012, retrieved 6 July 2012 from <https://canterburygeotechnicaldatabase.projectorbit.com/>

Crack locations were mapped in order to infer the general direction, magnitude and extent of the lateral ground movements. The mapping objectives changed in response to the varying situation following the two earthquakes. Observations after the 4 Sept 2010 Earthquake were principally for insurance claim settlements. The crack widths were recorded in property-by-property observations, but cracks were not tracked across property boundaries and only a portion of properties were mapped before the 22 Feb 2011 Earthquake. Cracks were mapped at a scale of 1:5000 to 1:10000 for about two weeks following the 22 Feb 2011 Earthquake in order to rapidly identify the extent of lateral spreading following the earthquake. The individual crack widths were not recorded. From early March 2011, cracks were generally mapped at a scale of 1:2000 and classified according to their maximum width. Cracks were tracked through properties in order to identify regional patterns.

The crack mapping is incomplete and only observations made by the mapping teams are presented. In particular, the mapping following the 4 Sept 2010 Earthquake was incomplete before the 22 Feb 2011 Earthquake occurred and subsequent mapping remains incomplete within the residential 'red zone' areas. Also, cracks in roads were often not able to be mapped because many were filled and the roads resealed before a mapping team arrived.

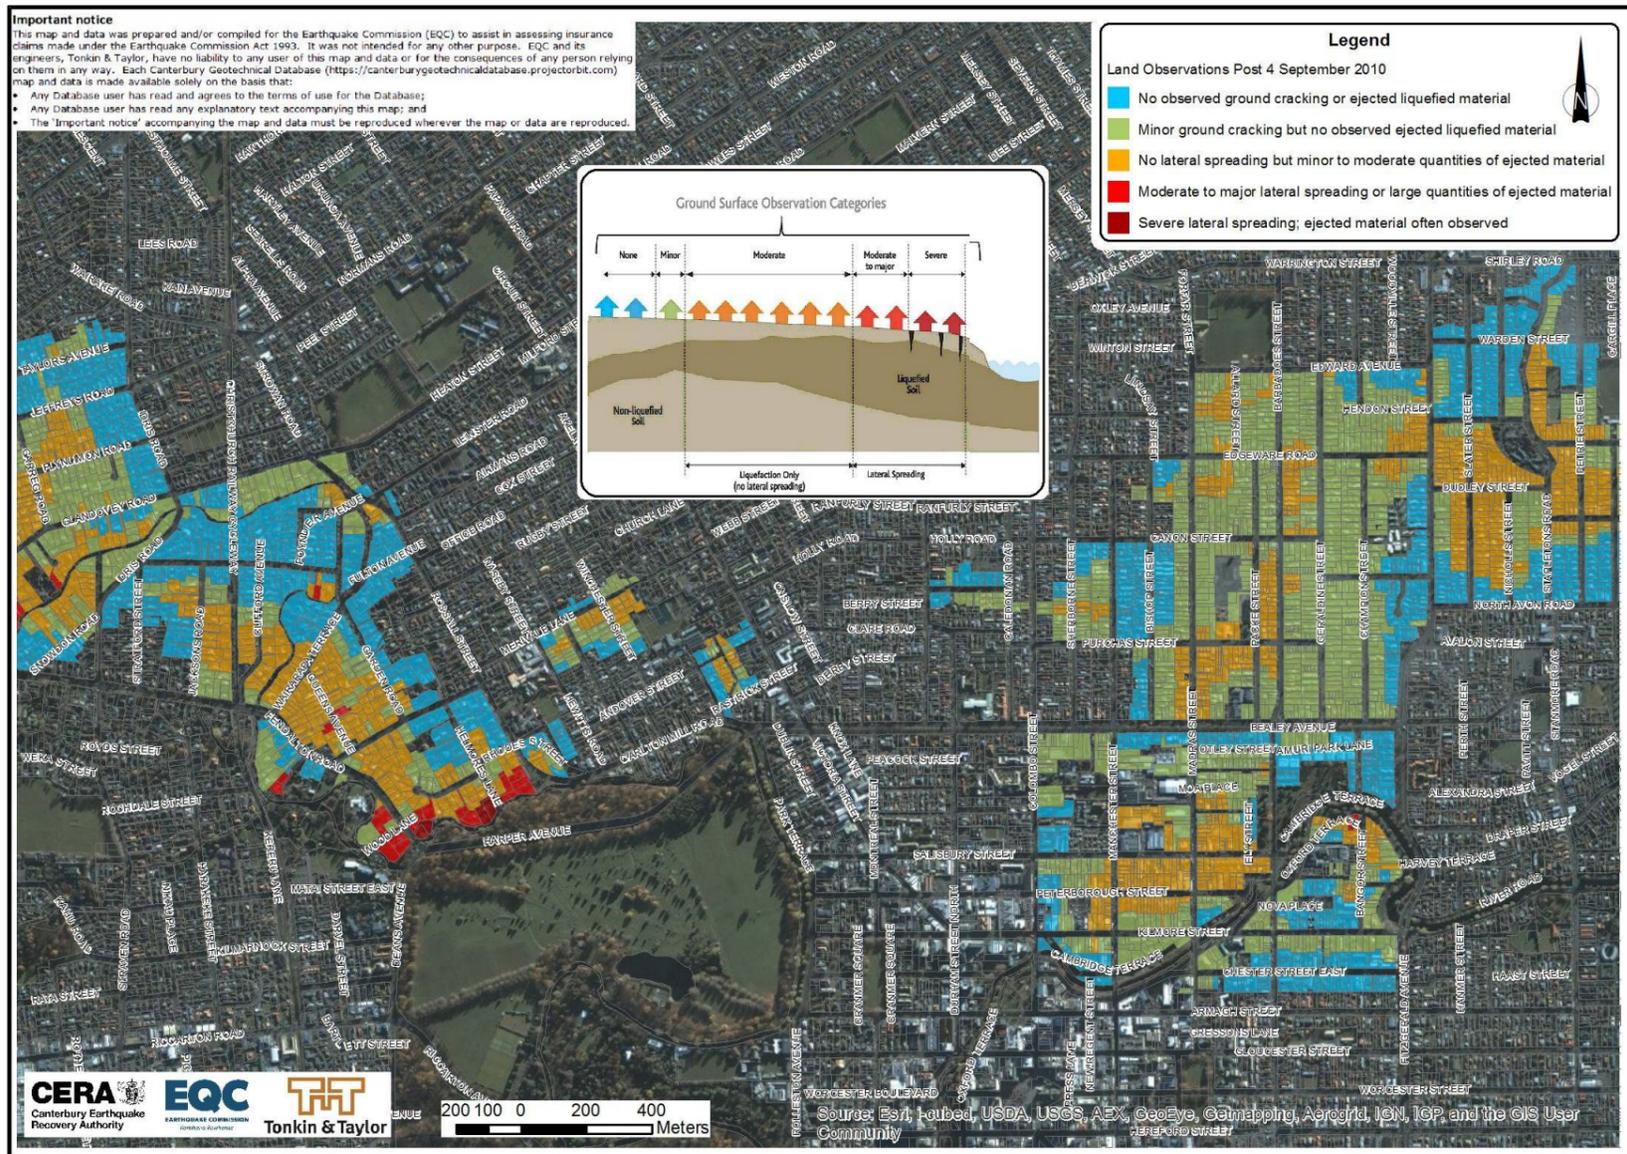
Figure 3 – Ground surface observations of liquefaction and lateral spreading following 4<sup>th</sup> September 2010 earthquake (from property-level ground mapping)

**Fig 3 – 5** Canterbury Geotechnical Database (2012) "*Liquefaction and Lateral Spreading Observations*", Map Layer CGD0300 - 23 May 2012, retrieved 6 July 2012 from <https://canterburygeotechnicaldatabase.projectorbit.com/>

The quantities of material ejected due to liquefaction and observations of lateral spreading were collated from on-foot rapid inspection of individual properties following each significant earthquake. The observations were categorized according to the quantity of ejected material observed on the ground surface and according to the presence or absence of evidence of lateral spreading. Each of these three categories was further subdivided according to the severity. The colour coding used on these maps has completely different meaning to colours used by CERA for land zoning and DBH for technical categories.

The observations were collected for the Earthquake Commission and were only made in residential areas. The mapping only identified liquefaction and lateral spreading that was visible at the surface at the time of inspection. Liquefaction may have occurred at depth without obvious evidence at the surface and evidence of liquefaction may have been removed before the inspection. (Removed material may be identifiable within the aerial photographs that were taken within a day or two of the earthquake.)

The properties were not all inspected between each pair of consecutive earthquakes (e.g. between 4 Sept 2010 and 22 Feb 2011) so the extent of the land deformations is most likely incomplete. Also, some observations following the 22 Feb 2011 and 13 Jun 2011 earthquakes could have been induced by preceding earthquakes.

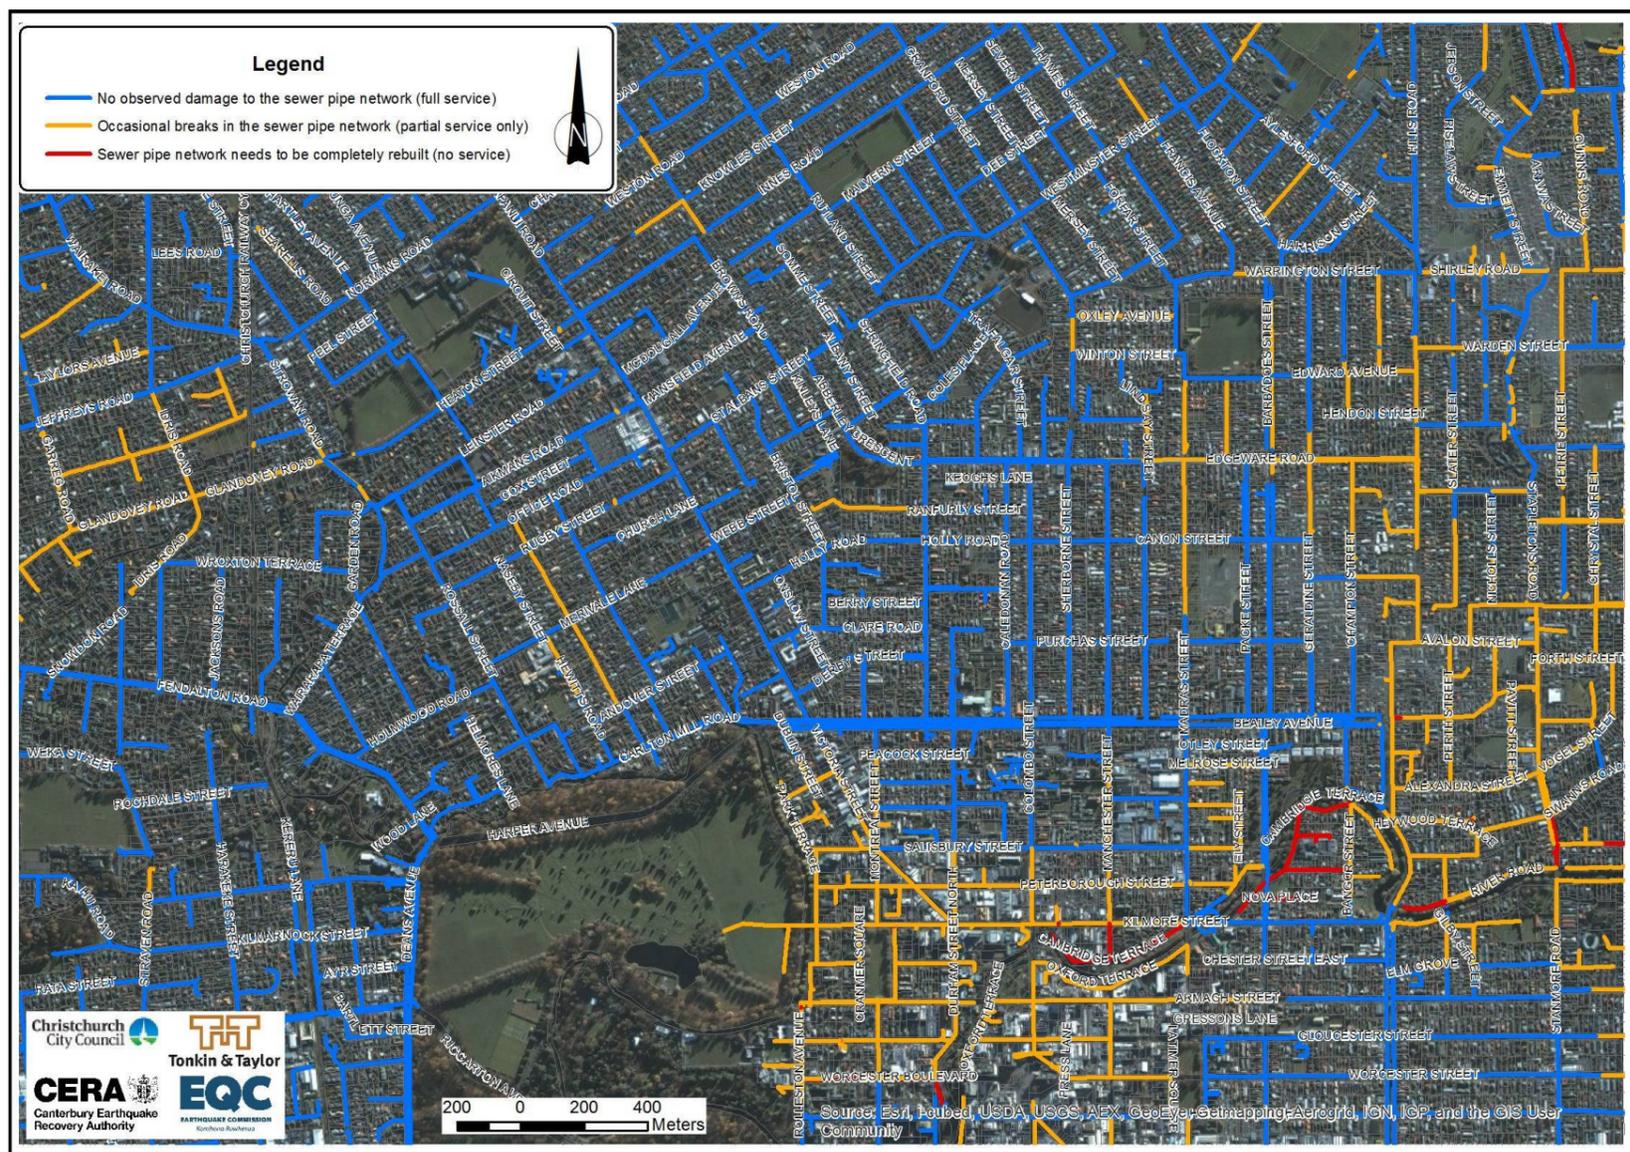
Figure 6 – Status of wastewater network as assessed at 20<sup>th</sup> April 2011 (NOW SUPERSEDED)

Since this map was compiled there has been significant additional assessment of the infrastructure network, so this map is now superseded. It is included only to show the best available information at the time of the zoning decisions. For an up to date assessment of the infrastructure network, SCIRT or the City Council should be consulted.

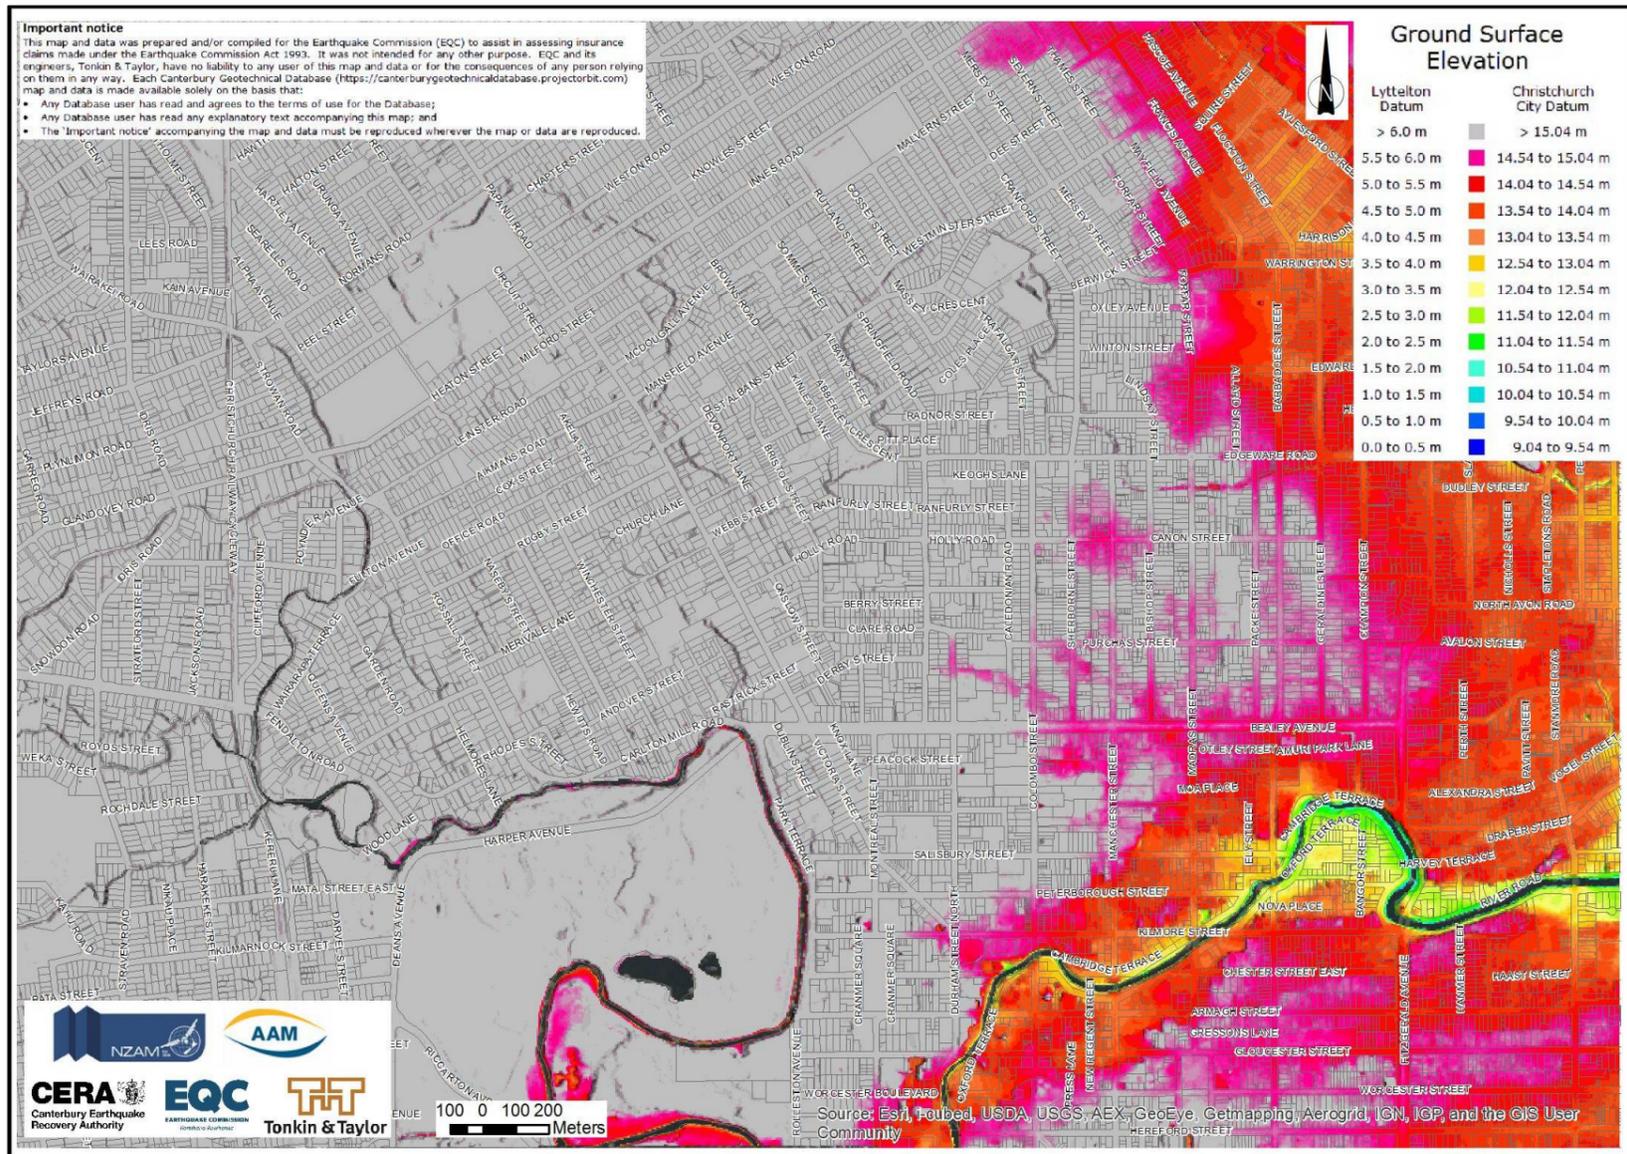
Figure 7 – Ground surface elevation from February 2012 LiDAR survey

**Fig 7** Canterbury Geotechnical Database (2012) "*LiDAR and Digital Elevation Models*", Map Layer CGD0500 - 23 May 2012, retrieved 6 July 2012 from <https://canterburygeotechnicaldatabase.projectorbit.com/>

LiDAR was acquired following each of the significant earthquakes. A digital elevation model was developed from each supplied LiDAR set by averaging the ground-return elevations within a 10 m radius of each grid point. Metadata supplied with the source LiDAR indicates a vertical accuracy of  $\pm 0.07$  to  $\pm 0.15$  m (excluding GPS error and Geoid modelling error) and 0.40 to 0.55 m horizontal. The pre-earthquake LiDAR has lower accuracy and sparser LiDAR point sets than the post-earthquake sets.

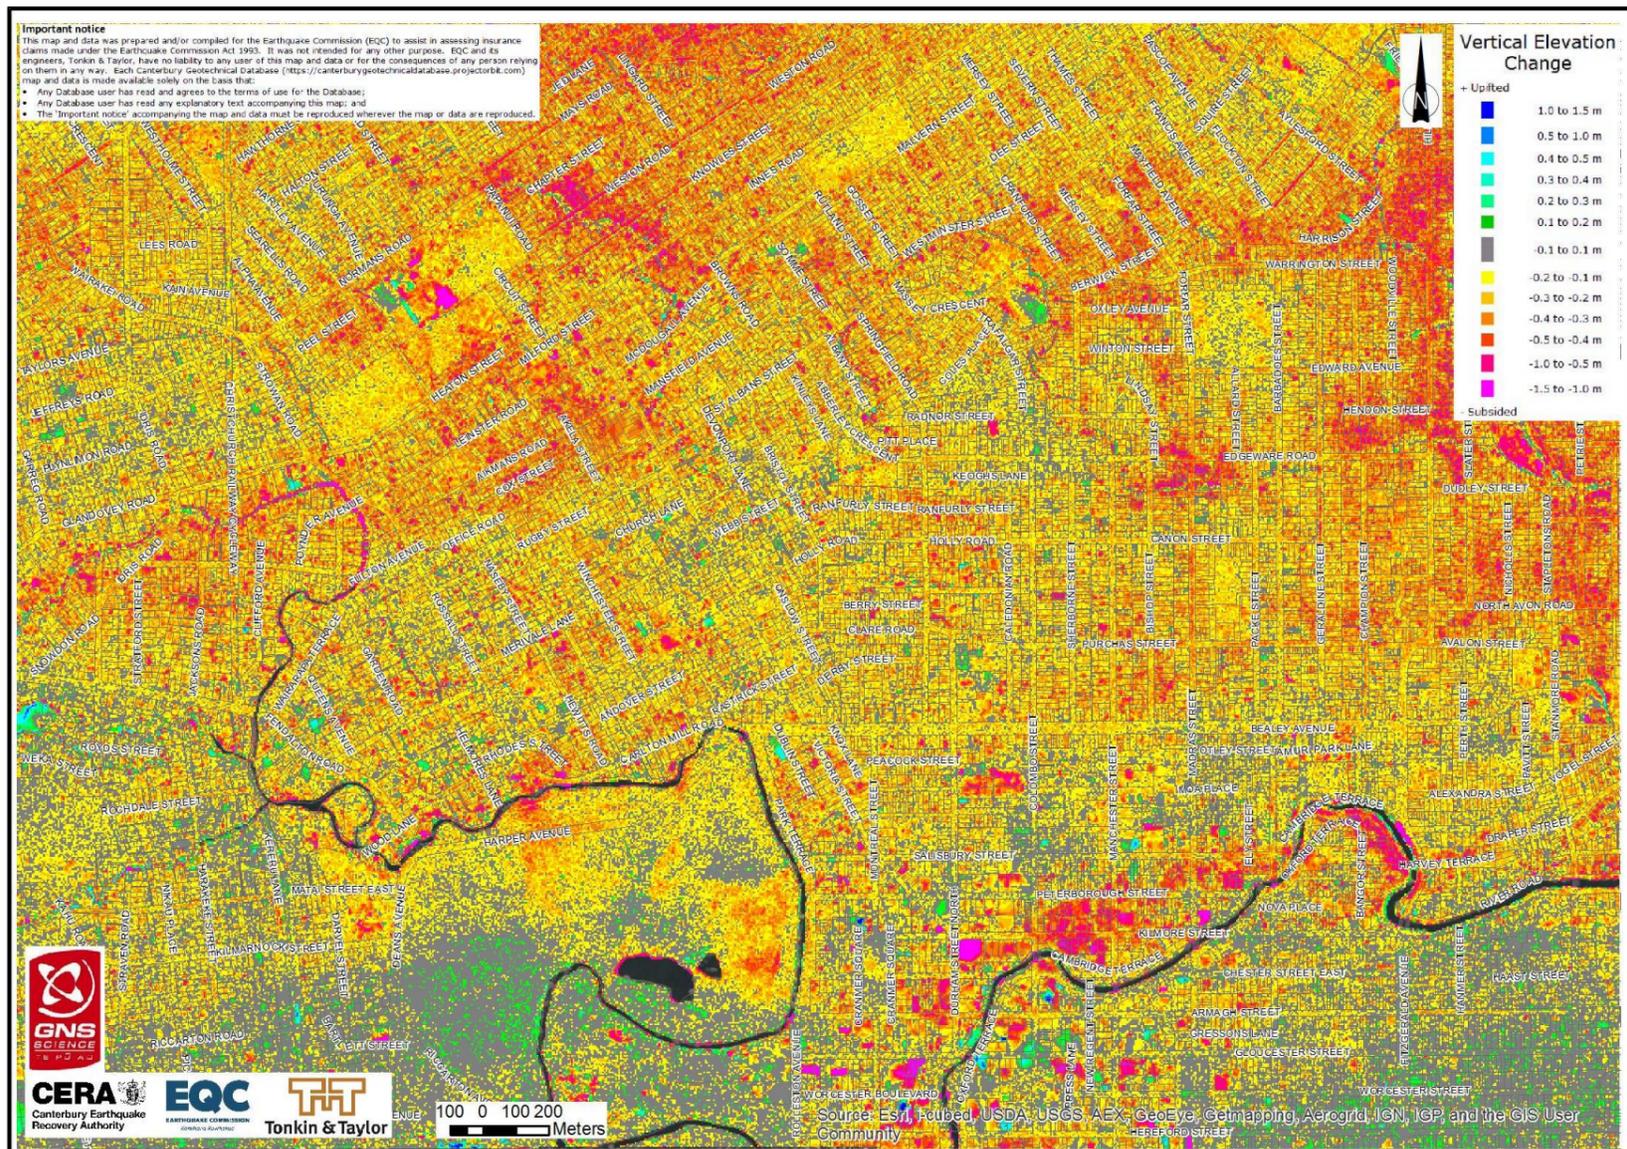
Figure 8 – Change in ground elevation between LiDAR in July 2003 and February 2012, with regional tectonic component of ground displacement removed

**Fig 8** Canterbury Geotechnical Database (2012) "*Vertical Ground Movements*", Map Layer CGD0600 - 23 May 2012, retrieved 6 July 2012 from <https://canterburygeotechnicaldatabase.projectorbit.com/>

Vertical elevation changes between LiDAR sets that approximate the vertical ground movements during significant earthquakes. Elevation changes were calculated as differences between pairs of Digital Elevation Models (DEM). Local vertical movements were calculated as the differences between the 'observed' elevation differences and the regional tectonic displacement from GNS Science dislocation models of the vertical tectonic movements during each earthquake.

All of the movements are differences between DEMs and are inherently less accurate than their source DEM's. The pre-earthquake source DEM is less accurate than the post-earthquake DEMs. Some of the DEMs have visually distinguishable lines or ripples within the colour bands that are almost certainly artefacts from the data acquisition and subsequent processing rather than from physical vertical movements. Notable examples are several approximately NNE-SSW swathes visible in the Feb 2011 difference set and an almost E-W line at 43.48°S in the 13 Jun 2011 difference set.
