14 February 2014

Arboricultural Report

Christchurch Hospital Acute Services Building Development Project

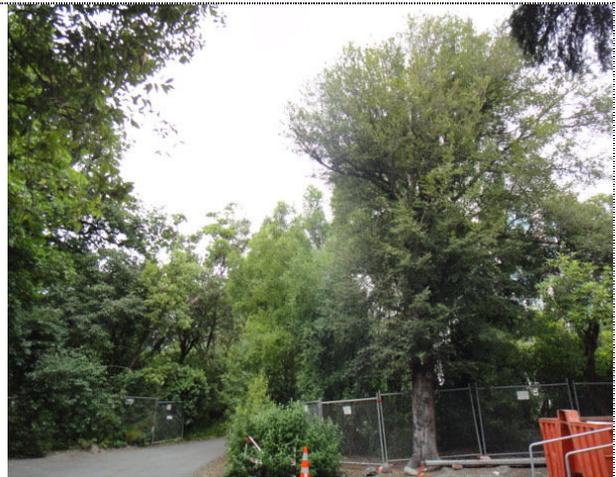
Within the area surrounding the existing temporary Fletchers Construction yard, there are groups of mixed native and exotic trees and shrubs, including species such as; *Maytenus*, *Ilex*, *Rhododendron*, *Fuscospora* (*Nothofagus*), *Podocarpus*, *Dodonaea*, *Sophora*, *Cordyline* and *Pittosporum*.

These trees and shrubs will be within the new building footprint and will require removal.

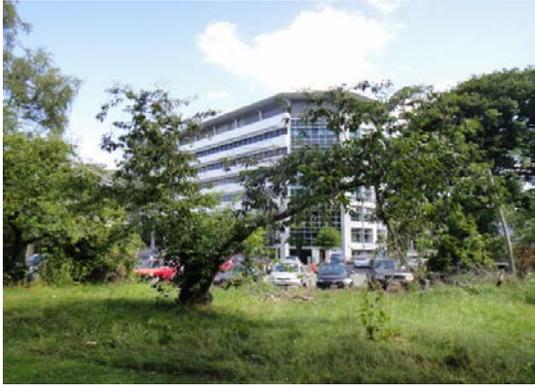
Tree ID:	106458

Tree Species:	Yoshino Cherry (<i>Prunus x Yedoensis</i>)	
Protection Status:	Nil	
Age Class:	Over-Mature	
Height:	6.0m	
Canopy Spread:	12.0m	
DBH:	0.90m	
Health:	4 (Poor)	
Form:	4 (Poor)	
Overall Condition:	4 (Poor)	
Comments:	Tree to be removed. Within new building footprint.

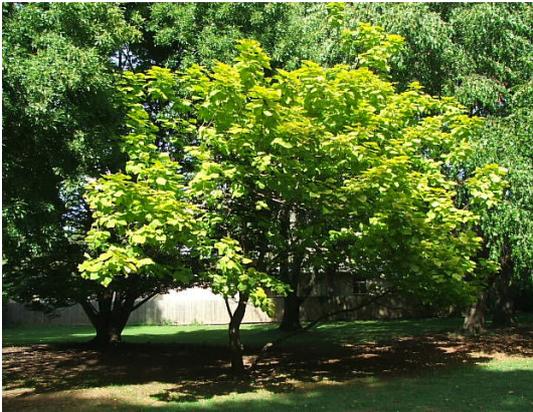
Tree ID:	106464

Tree Species:	Golden Indian Bean Tree (<i>Catalpa bignonioides</i> 'Aurea')	
Protection Status:	Nil	
Age Class:	Mature	
Height:	8.0m	
Canopy Spread:	8.0m	
DBH:	0.26m	
Health:	3 (Average)	
Form:	3 (Average)	
Overall Condition:	3 (Average)	
Comments:	Tree to be removed. Within new building footprint.

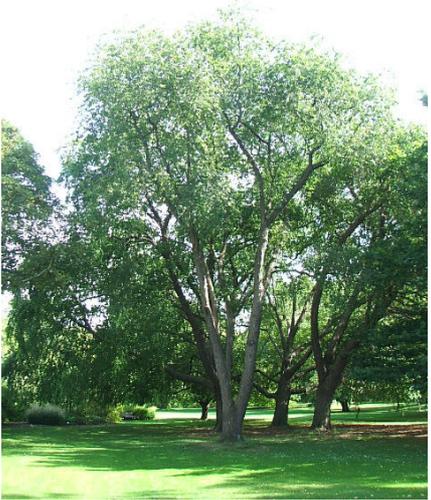
Tree ID:	106466

Tree Species:	Bird Cherry (<i>Prunus padus</i>)	
Protection Status:	Nil	
Age Class:	Mature	
Height:	18.0m	
Canopy Spread:	14.0m	
DBH:	0.85m	
Health:	2 (Good)	
Form:	3 (Average)	
Overall Condition:	3 (Average)	
Comments:	Tree to be removed. Within new building footprint.

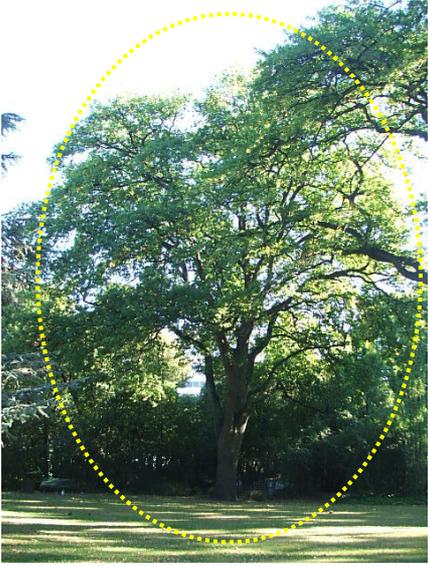
Tree ID:	CH-10

Tree Species:	English Oak (<i>Quercus robur</i>)	
Protection Status:	Nil	
Age Class:	Mature	
Height:	21.0m	
Canopy Spread:	25.0m	
DBH:	1.05m	
Health:	3 (Average)	
Form:	3 (Average)	
Overall Condition:	3 (Average)	
Comments:	<p>Tree should be removed due to change in use of area.</p> <p>The tree is located within the vicinity of the new building, and lateral reduction pruning would be required if the tree is retained.</p> <p>Tree as previous structural failures, and further failures are likely following changes to the site.</p>

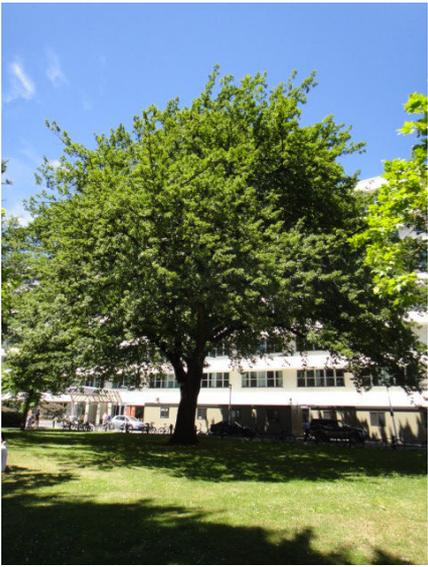
Tree ID:	CH-28

Tree Species:	Turkey Oak (<i>Quercus cerris</i>)	
Protection Status:	Nil	
Age Class:	Mature	
Height:	22.0m	
Canopy Spread:	28.0m	
DBH:	1.2m	
Health:	2 (Good)	
Form:	2 (Good)	
Overall Condition:	2 (Good)	
Comments:	<p>This tree is in good condition and should be retained and protected if possible. If possible works within the drip line (canopy spread) should be limited to the existing carriageway.</p> <p>A bridging platform on pile foundations could be constructed within the drip line for a vehicle turning circle. However, damage to the root system of the tree and potential adverse effects on tree health may still occur.</p> <p>It may be possible to construct a turning bay east of this tree, outside the tree drip line, resulting in the removal of tree CH-29.</p> <p>Minor pruning may be required over the carriageway to increase clearance for over-height loads.</p>

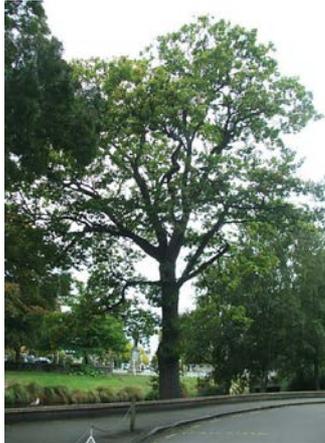
Tree ID:	E-03

Tree Species:	Species: English Oak (<i>Quercus robur</i>)	
Protection Status:		
Age Class:	Over-Mature	
Height:	17.0m	
Canopy Spread:	18.0m	
DBH:	0.8m	
Health:	4 (Poor)	
Form:	4 (Poor)	
Overall Condition:	4 (Poor)	
Comments:	The lowest branch on the southern side of the tree may require clearance pruning for over-height loads to access the site.

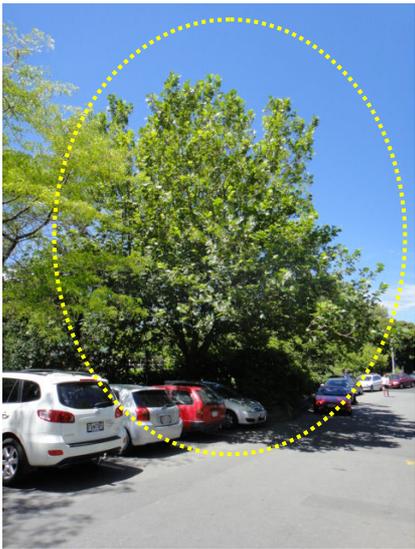
Tree ID:	4212

Tree Species:	London Plane <i>(Platanus x acerifolia)</i>	
Protection Status:	Resource Consent	
Age Class:	Mature	
Height:	11.0m	
Canopy Spread:	16.0m	
DBH:	0.6m	
Health:	3 (Average)	
Form:	3 (Average)	
Overall Condition:	3 (Average)	
Comments:	<p>This tree requires maintenance pruning to improve clearance over the drive and car parking area.</p> <p>This will involve the removal of three branches that are up to 12.5cm in diameter (measured at the stem attachments) and other minor branches.</p> <p>It is expected that this work will improve the form and appearance of the tree, and that less than 20% of the existing canopy will be removed.</p> <p>The proposed pruning is to be carried out by a suitably experienced and qualified arboricultural contractor.</p>

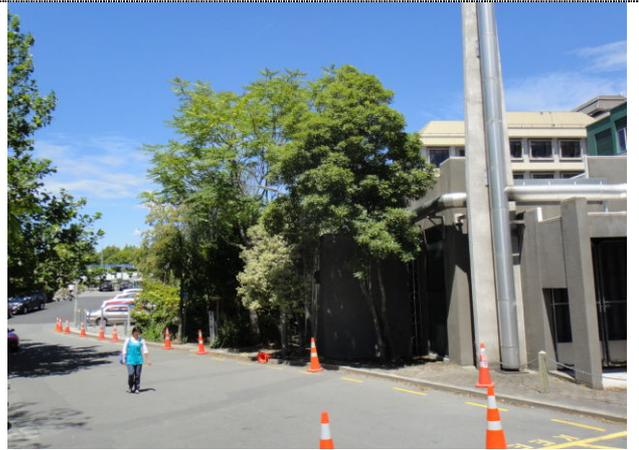
Within the area surrounding Generator Building, there are groups of mixed native and exotic trees and shrubs, including species such as; *Cordyline*, *Pittosporum*, *Dodonaea* and *Ailanthus*.

Some of these trees and shrubs may be affected by site access, and may require pruning or removal.
