CHRISTCHURCH CATHEDRAL PROPOSED REINSTATEMENT

Archaeological Assessment of Effects
Prepared for the Cathedral Working Group
November 2016

Archaeological Assessment of Effects of the proposed reinstatement of ChristChurch Cathedral, 100 Cathedral Square, Christchurch

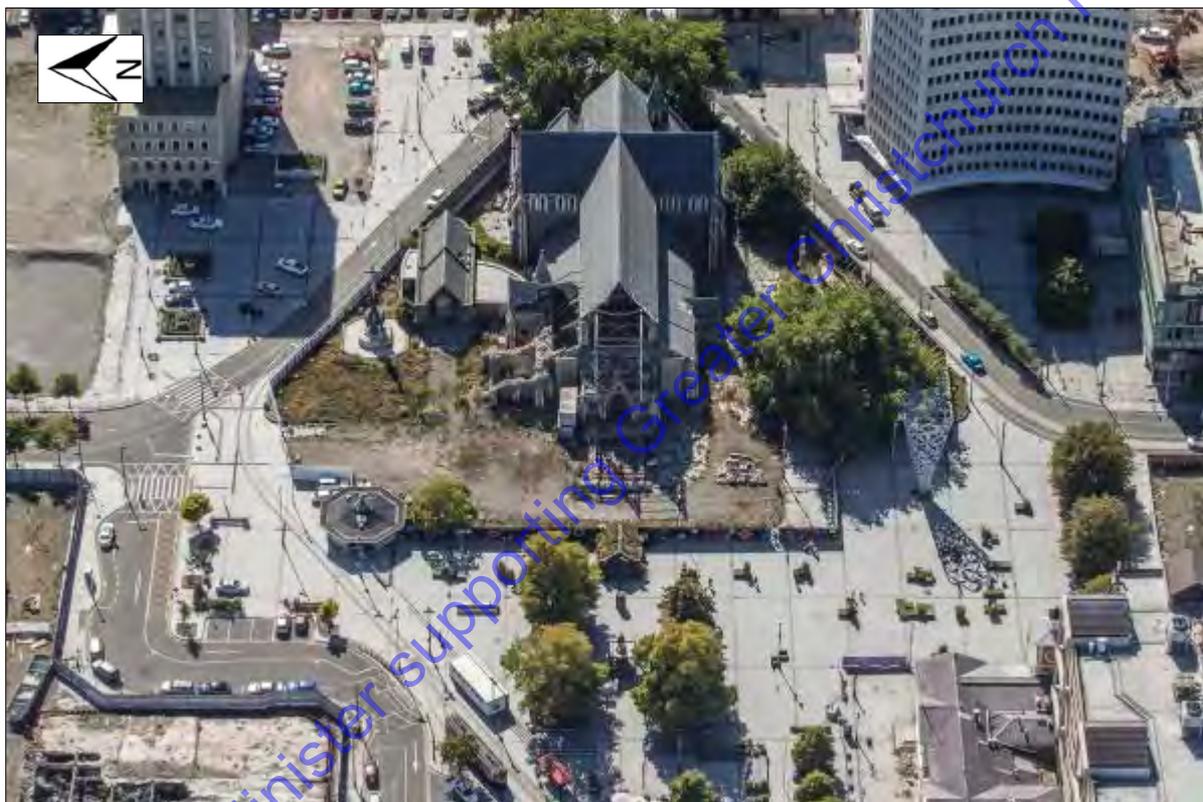
Figure 3: Detailed aerial photographic view of the ChristChurch Cathedral site and east end of Cathedral Square in 2016. *Image: Stuff.co.nz*

The ChristChurch Cathedral is situated in the eastern half of Cathedral Square in the centre of the Christchurch central business district (Figure 3). The setting of the cathedral and the square is dominated by hard landscaping, multi-storey buildings, roading and the tramway. This urban setting is softened slightly by mature trees located within the fenced Cathedral precinct and the remains of earth disturbed and deposited immediately after the 2011 earthquake. The Cathedral building, including the former visitor centre, sits on a very slightly elevated position above the roadway that runs eastwards around the building from Colombo Street.

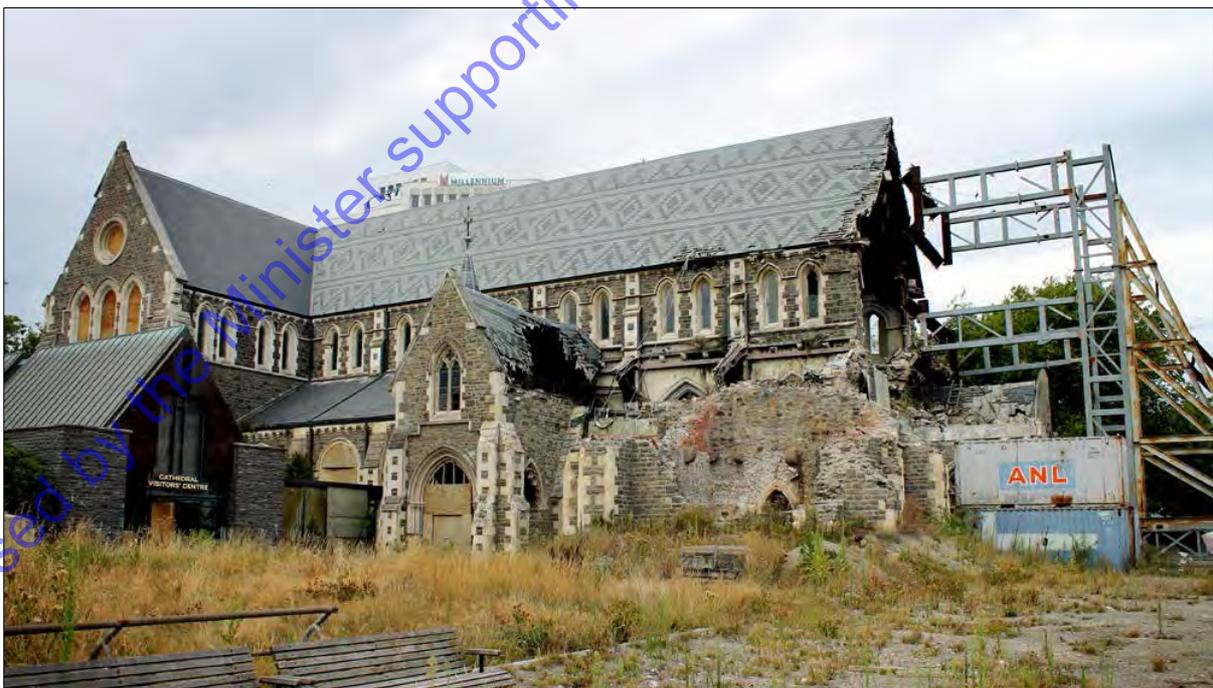
Figure 5: The Cathedral after the series of seismic events during 2011 and the partial demolition of the tower. *Photograph: <http://www.vengavalevamos.com/2016/03/christchurch-new-zealand/>*

The spire and upper levels of the tower were lost in the February earthquake. The tower has since been reduced in height to approximately 3 metres above the surrounding ground level (Figure 5). The construction was revealed to include large areas of solid brick masonry, rubble stone infill and cement mortar (JGA 2013).

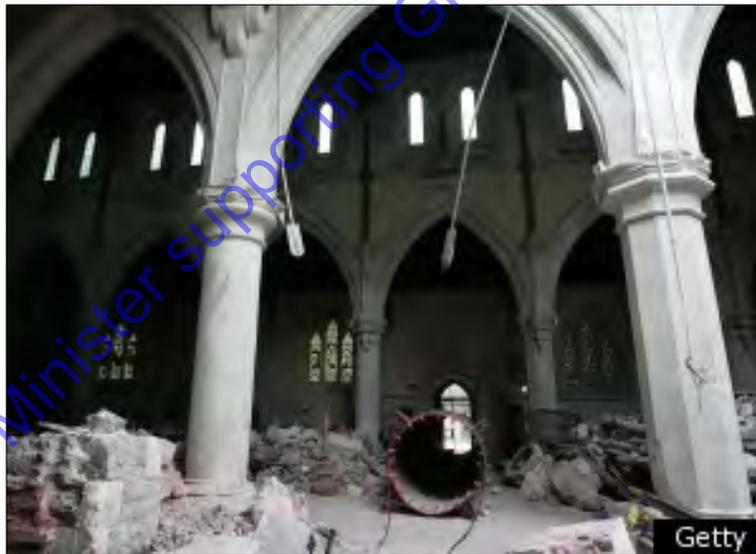
Figure 7: A view of the Cathedral interior after the earthquake with building damage and collapsed material evident. Image: Getty/Huffington Post

Inside the building there are a number of important fixtures and artefacts, including memorial tablets in stone and brass, carved timber panelling and screens, a stone pulpit, altar table and font and the effigy of Bishop Harper (Figure 6). The floors are finished with intricate patterns of encaustic tiles, including a dramatic panel leading up the centre of the nave, and illustrations of the "Four Ships" in the chancel floor. There are five panels of similar tiles at dado height on the west and north walls. At least one of these panels collapsed in the 2011 seismic events (Figure 7).

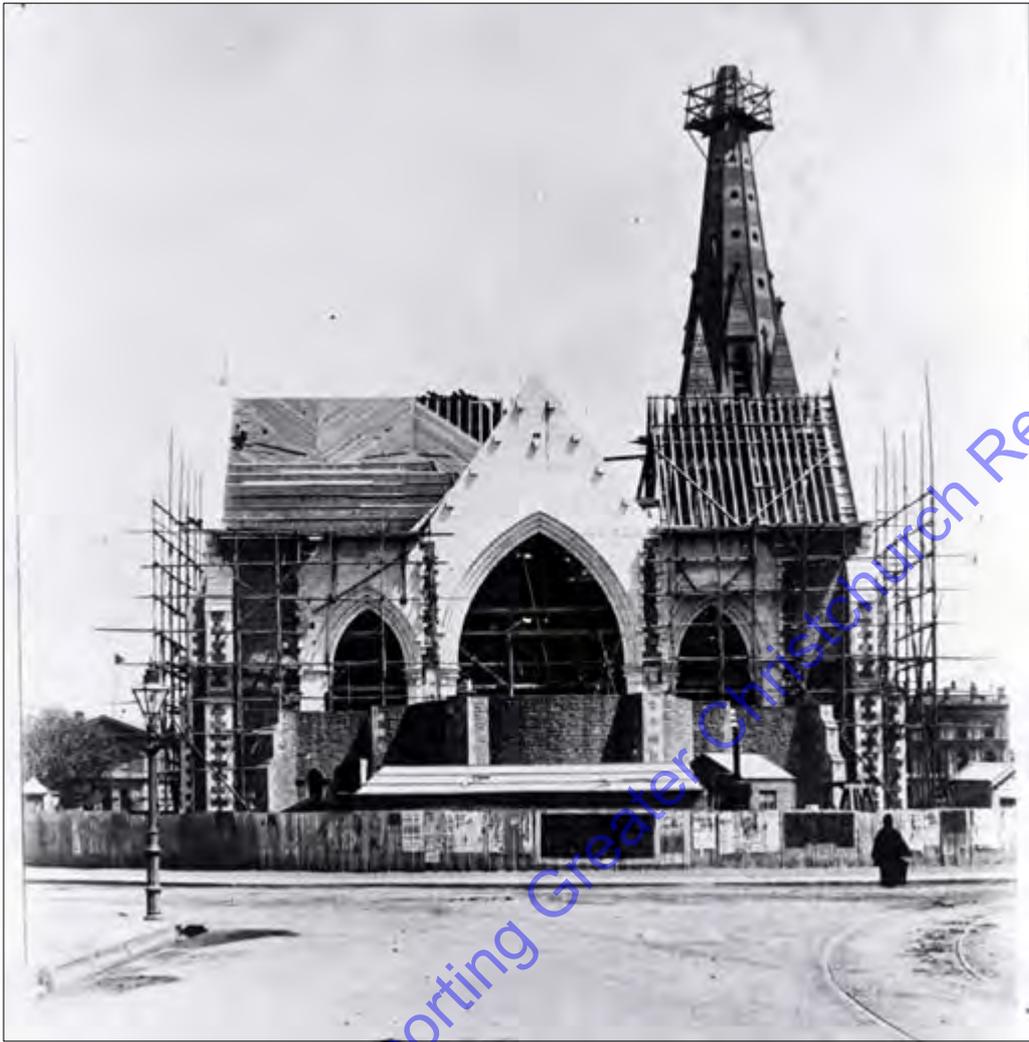
Figure 8: A view of the Cathedral under construction around 1880; the transept roofs are being erected and the eastern apse is partly built. *Photograph: Christchurch City Libraries*

Foundations for the cathedral were laid on 16th December 1864 under the supervision of Robert Speechly (1840-1884), after much fundraising both in England and New Zealand. Speechly, who had trained as an architect in London and worked for several leading Gothic Revival architects including William Slater and Alfred Waterhouse, was appointed resident architect to supervise the construction of the Christchurch Cathedral in 1864. The decision by the Cathedral Commission to appoint Speechly, rather than the leading local architect, Benjamin Woolfield Mountfort (1825-1898), led to an intense debate in the Christchurch newspapers. Scott supported the idea of appointing a local architect who would be familiar with the colony's conditions, and he was impressed by what he knew of Mountfort's buildings. However, the Cathedral Commission declined to accept Scott's advice, reiterating instead their concerns about the abilities of local architects (Figure 8).

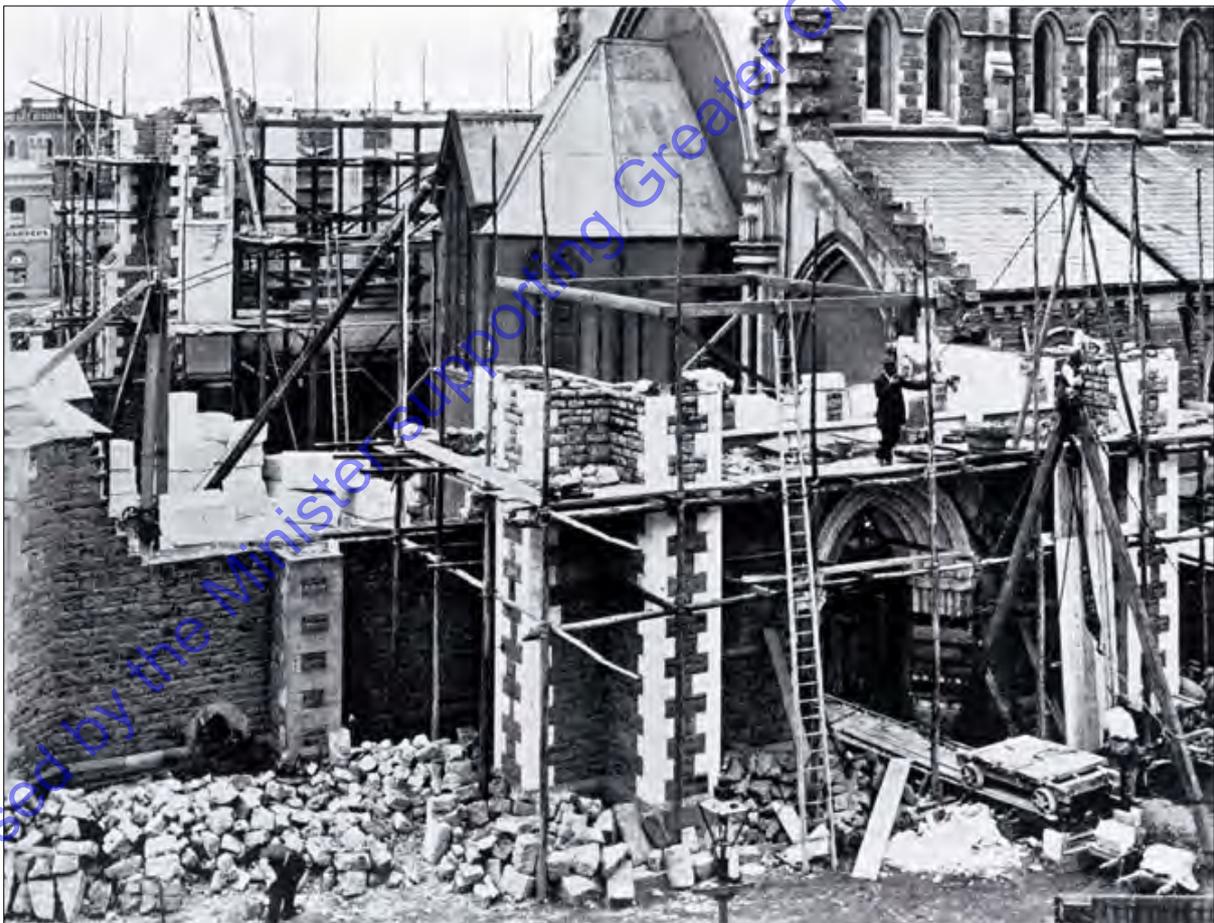
Figure 9: The chancel and apse under construction circa 1901. *Photograph: Christchurch City Libraries*

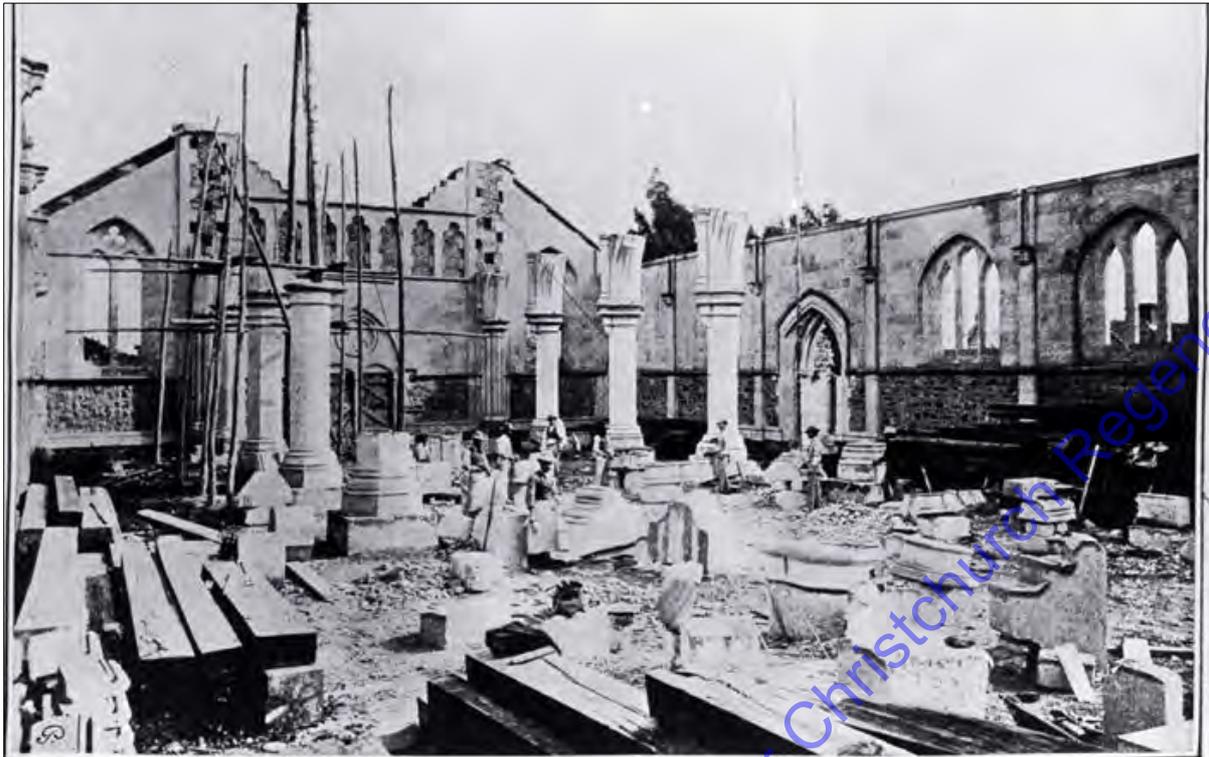
CHRISTCHURCH CATHEDRAL AS IT APPEARED IN 1878, THREE YEARS AFTER THE FIRST SERVICE IN IT WAS HELD.

Figure 11: An interior view of the Cathedral nave under construction circa 1878, looking towards the western end. The concrete bases for the stone columns are visible although the foundation level below the unfinished walls is harder to distinguish. Photograph: Christchurch City Libraries

- The finished surface of the 'concrete' foundations were described as though of 'solid rock'.
- An 1878 reference (Press, 5 June 1878, page 4) noted that the base of the nave columns (weighing 1.5 tonnes) each had a concrete foundation (Figures 11 and 12).

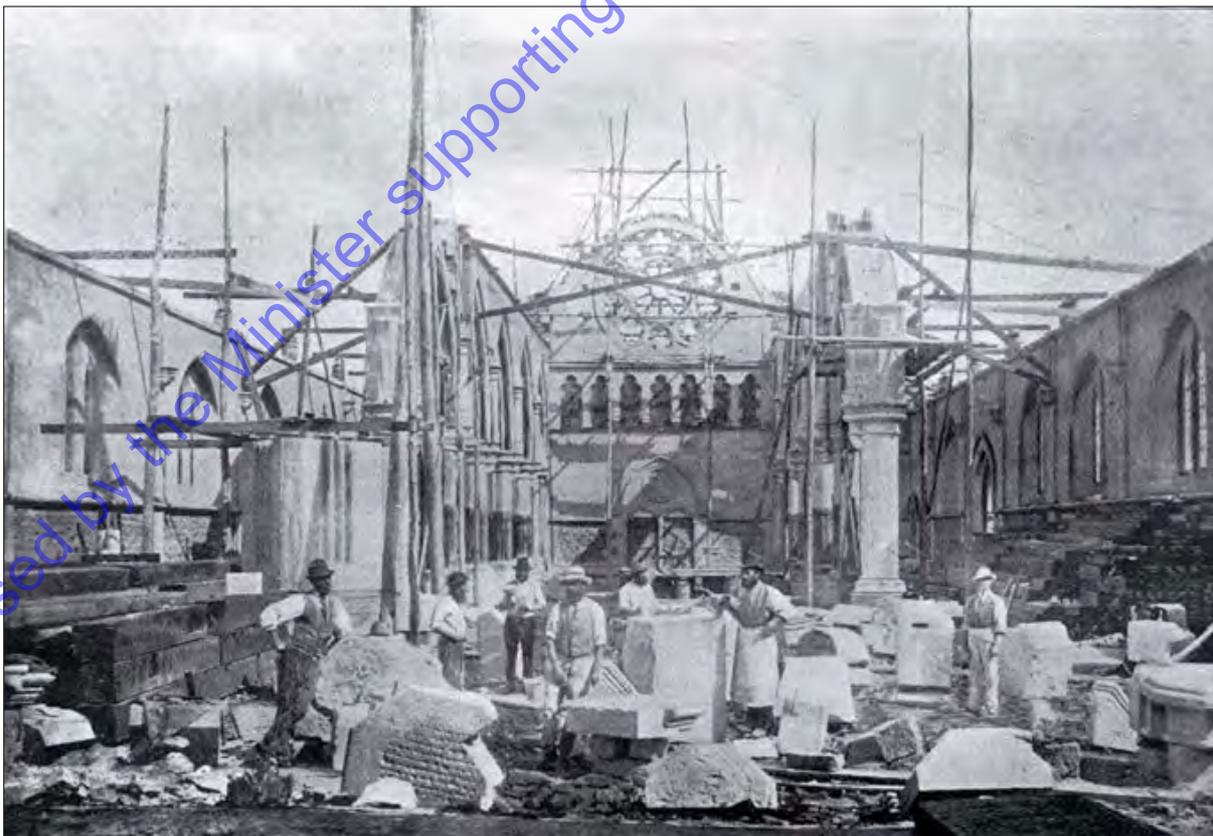
Figure 12: A slightly later view of the interior progress taken circa 1879 with the Rose window under construction. Photograph: Christchurch City Libraries

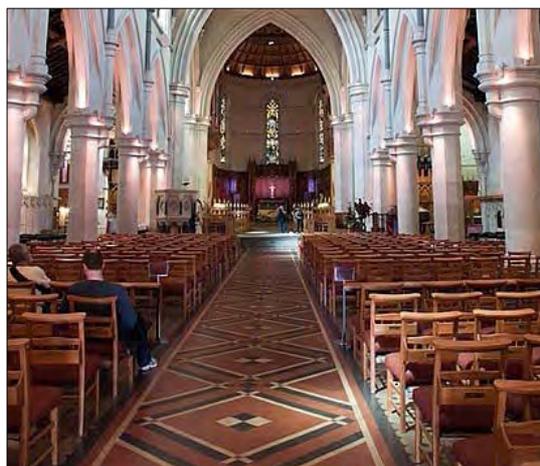
Figure 13: A view of the nave floor with the Minton tile covering. Image: www.eyeofthefish.org

This implies that there is little in the way of a sub-floor space beneath the floor surface with the 'floor' formed in concrete. This was then laid with ceramic tiles manufactured by Minton and commonly referred to as *encaustic* tiles - ceramic tiles in which the pattern or figure on the surface is not a product of the glaze, but of different colours of clay, often two but up to as many as six colours. A close-up of the 1878 interior view (refer to Figure 11), shows the base of the columns resting on a large block foundation, presumably of concrete. The void between the ground level and top of this block appears to have been filled with the concrete referred to above. The floor levels at the eastern end of the Cathedral were raised above the nave and aisle floor level; two steps up to the choir from the chancel and then six steps from the sanctuary to the altar area (Lyttelton Times, 11 February 1865, page 5). At the east end of the building, in the apse below the floor level, two stone stair cases led down below the floor level into a small basement area containing a passageway and space for the organ blower.

The Minton tiles noted in 1881 referred to the company founded by Thomas Minton in 1793 in Stoke-on-Trent, Staffordshire, England. Minton and his successors formed various partnerships during the nineteenth century, to produce domestic tableware and later, earthenware tiles. The partnership of Minton, Hollins and Company, formed in 1845, became particularly noted for their ceramic and encaustic tiles which fuelled the Victorian enthusiasm for durable and decorative wall and floor finishes. Minton's were a significant international manufacturer and supplier of tiles for churches and other public buildings across the developed world by the late nineteenth century (The Potteries 2016). The laying of the nave floor tiles was completed by 3rd June 1881 (Star, 3 June 1881, page 3) with the grey slate of the basement level of the Tower probably completed soon after (JGA 2013).

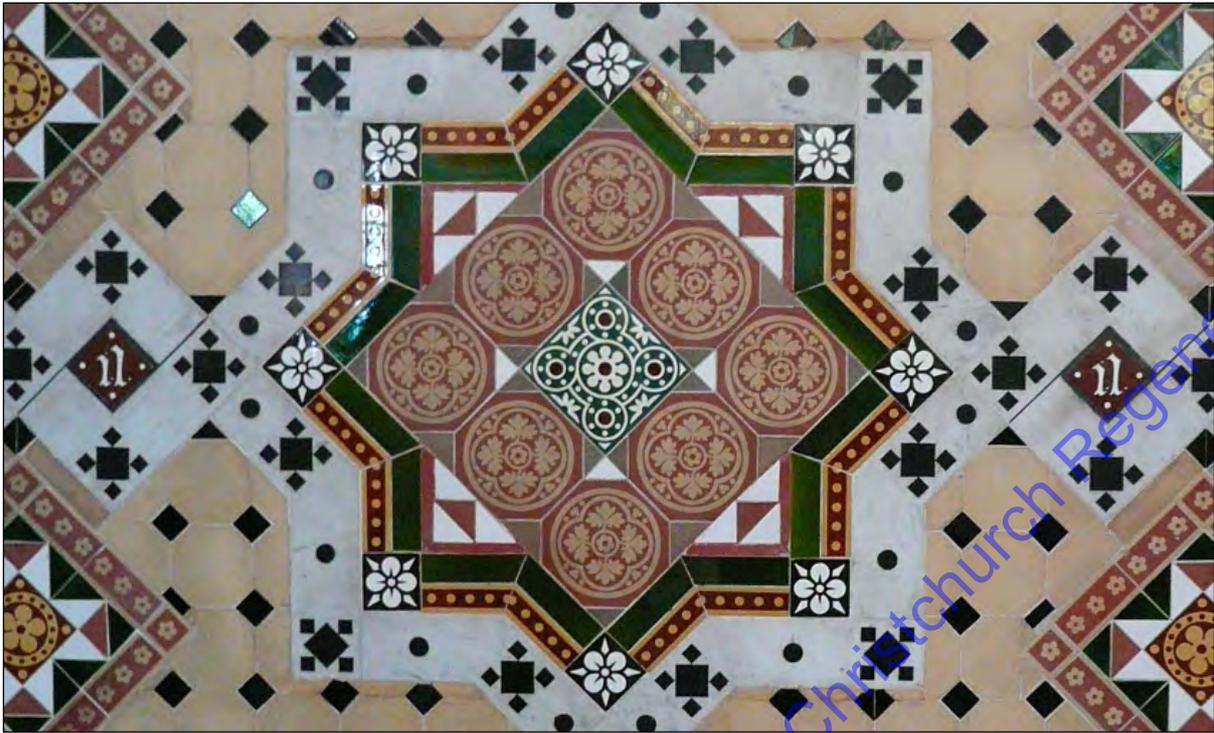
Figure 14: Maw and Co tiles from the Creyke Porch. Image: www.tilesoc.org.uk

The West porch, known as the Creyke Porch was added to the Cathedral building in 1894 and its floor is recorded as being tiled with 'Maw and Co.'s incised tiles, with cement inlays' (Press, 15 June 1894, page 5; Figure 14). Maw & Co were a well-known and successful ceramic tile manufacturer founded in 1850 and based in Broseley, Staffordshire, England. They were known for the quality and highly intricate production of their encaustic tiles and continued manufacturing until c.1970 (Maws Craft Centre 2016). The porch architect was Benjamin Mountfort and it is possible that he also may have also designed the tiled floor pattern.

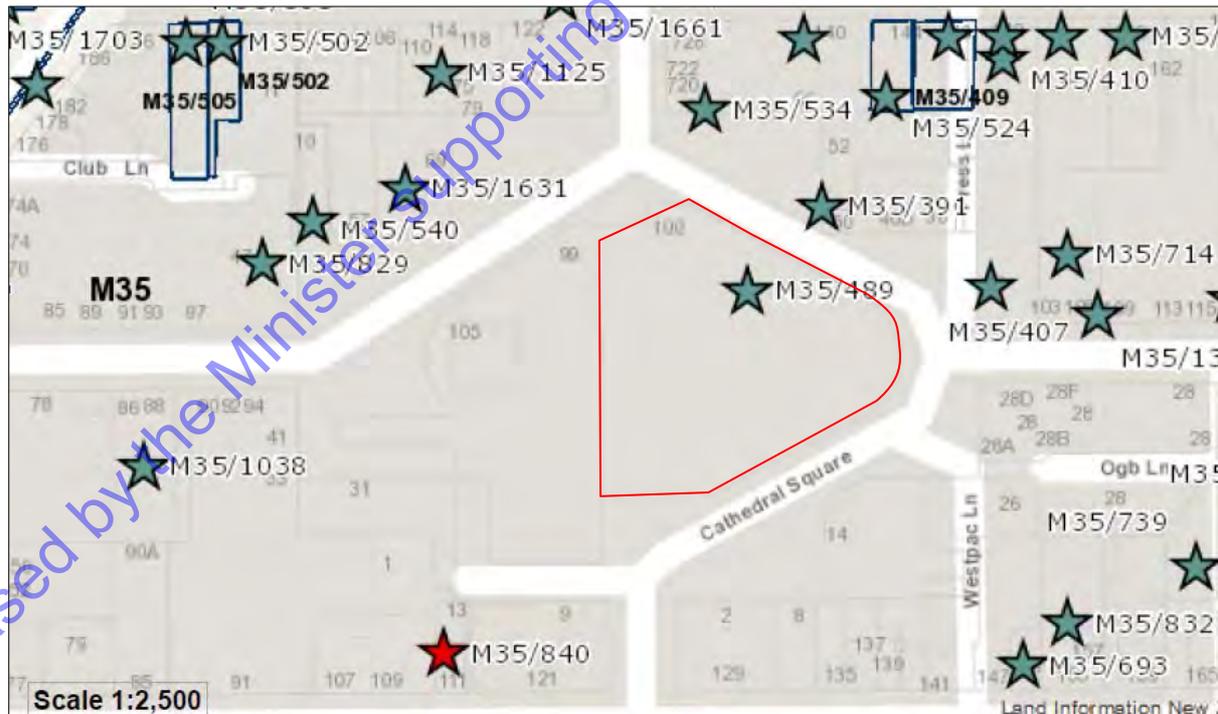
Figure 15: Recorded archaeological sites within the Cathedral assessment area (outlined in red); site M35/489 is located within the assessment area. Source: New Zealand Archaeological Association

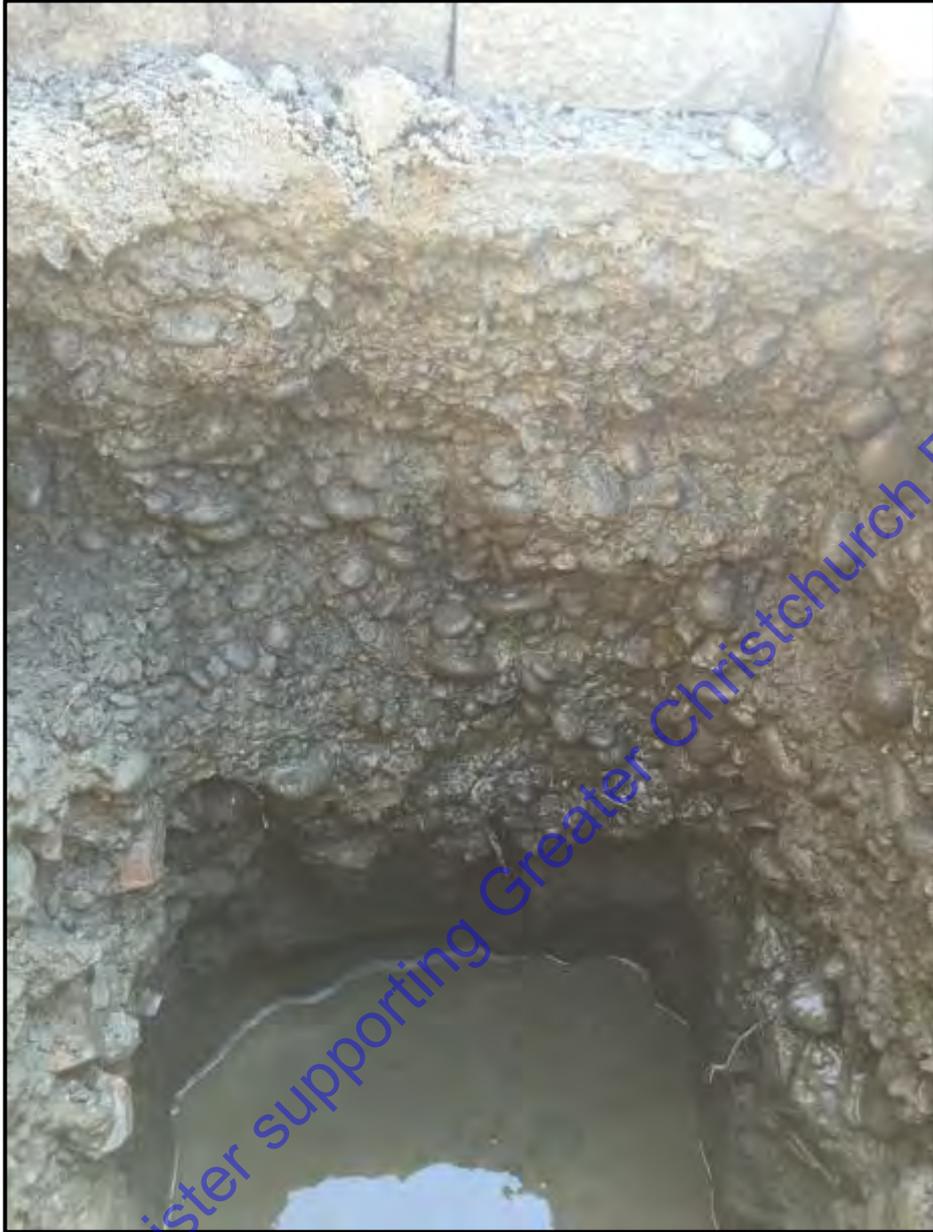
Figure 2. Looking at the northern baulk of the hydro excavated trench at 105 Cathedral Square, Christchurch Central, Christchurch. Image: Teri Anderson 31/08/2016.

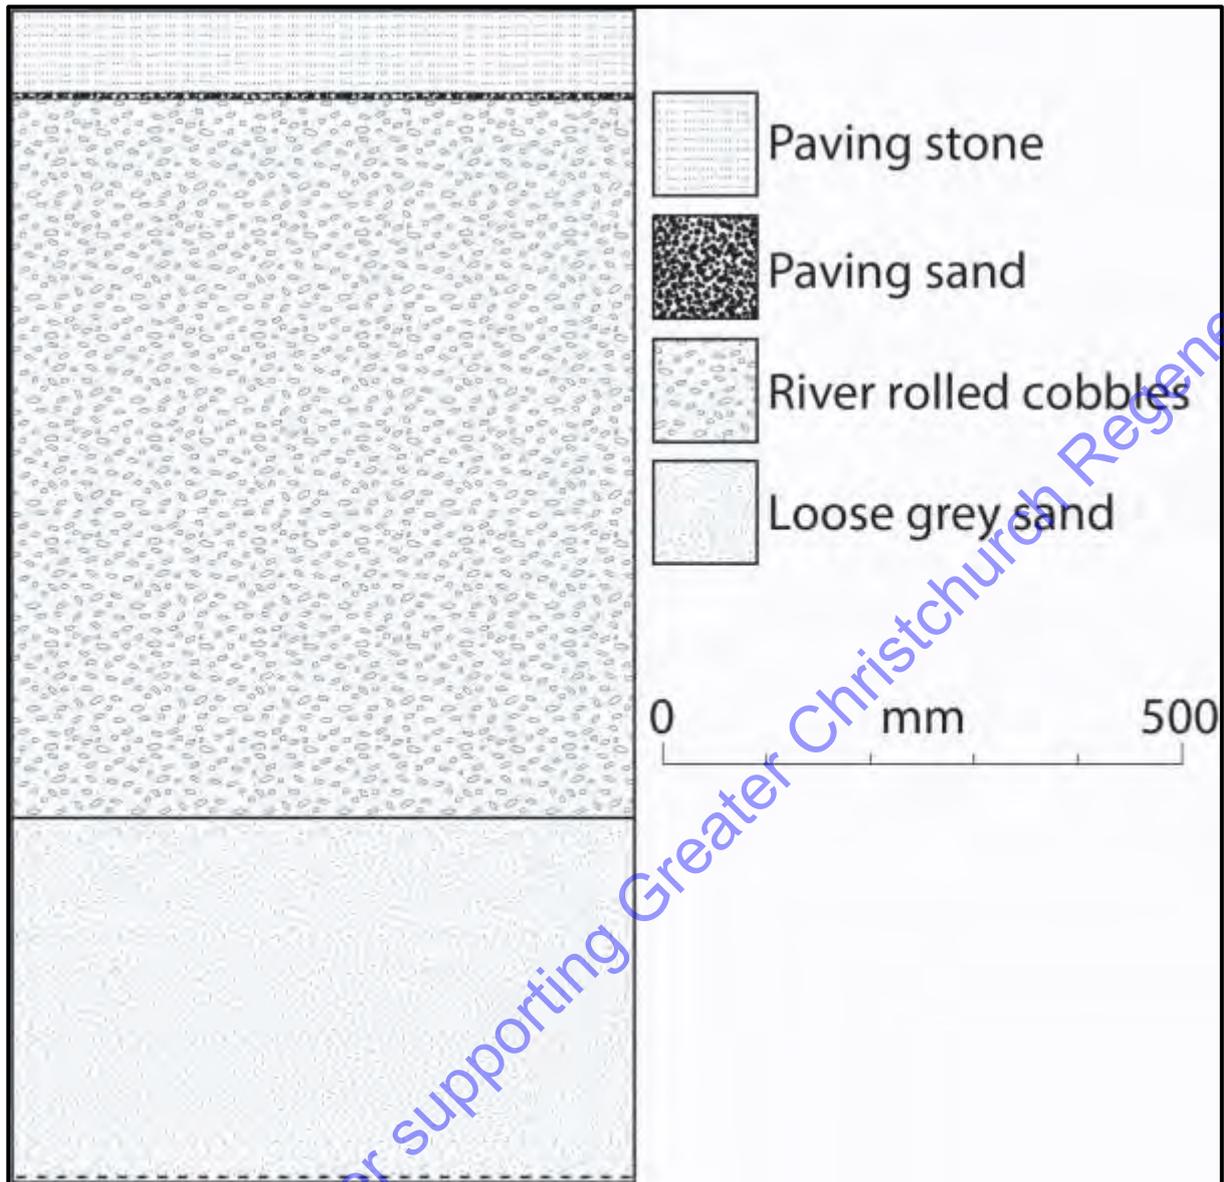
Figure 3. Stratigraphic profile of the northern baulk. Image: Teri Anderson.
