Official Information Act request relating to a Cabinet paper circa 14/12/2010 CER - DBH Guidance

Report of the Ad Hoc Cabinet Committee on Canterbury Earthquake Recovery: Period Ended 21 January 2011

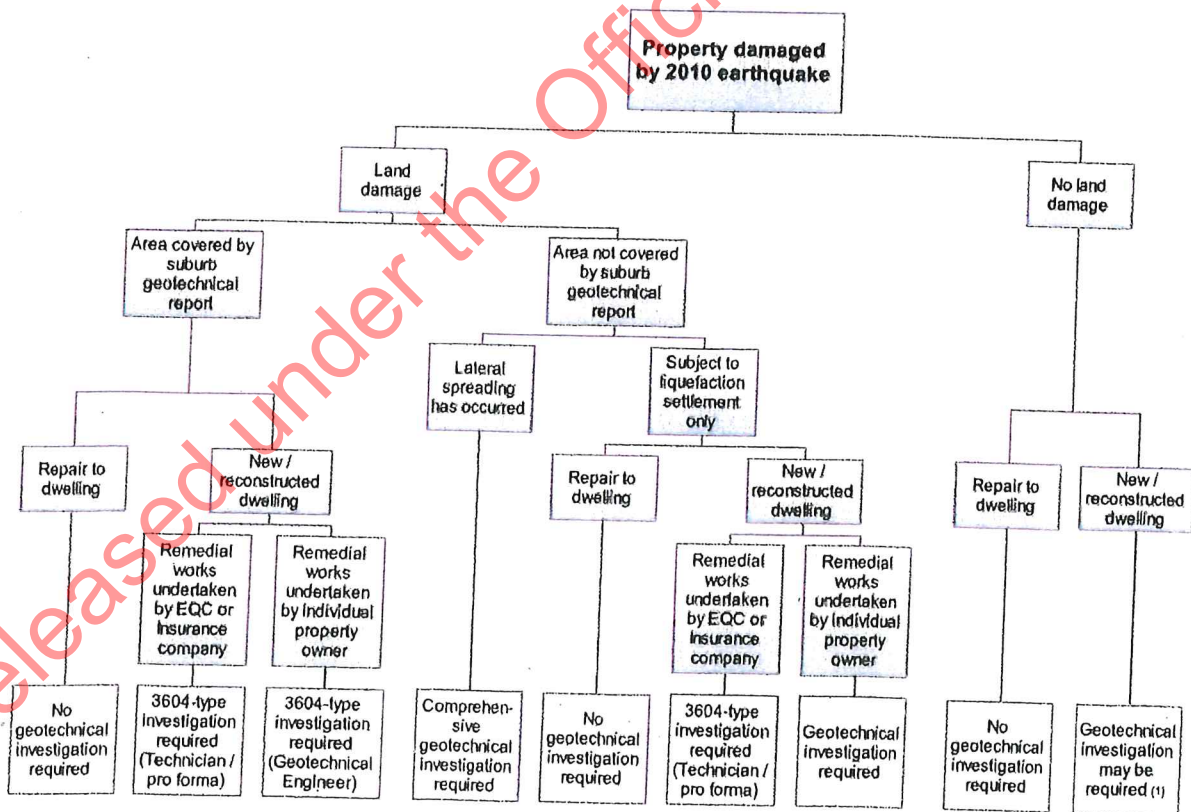
Summary of relationship between individual site investigation and land damage

Suburb geotechnical reports are being prepared for the Earthquake Commission; the reports will investigate the deeper soil profiles and the liquefaction hazards for a number of suburbs affected by liquefaction in Christchurch. They will address the geotechnical seismic risk/issues for the suburb as a whole and provide sufficient information for the design of structures for this hazard.

Field investigations for individual sites may, therefore, be limited to Scala Penetrometer Testing and hand augers to confirm that the upper two metres of land meets NZS 3604 requirements for static bearing. It is expected that these reports need not be more than a one page letter or template that details the observed damage and provides confirmation that the upper two metres has sufficient bearing capacity.

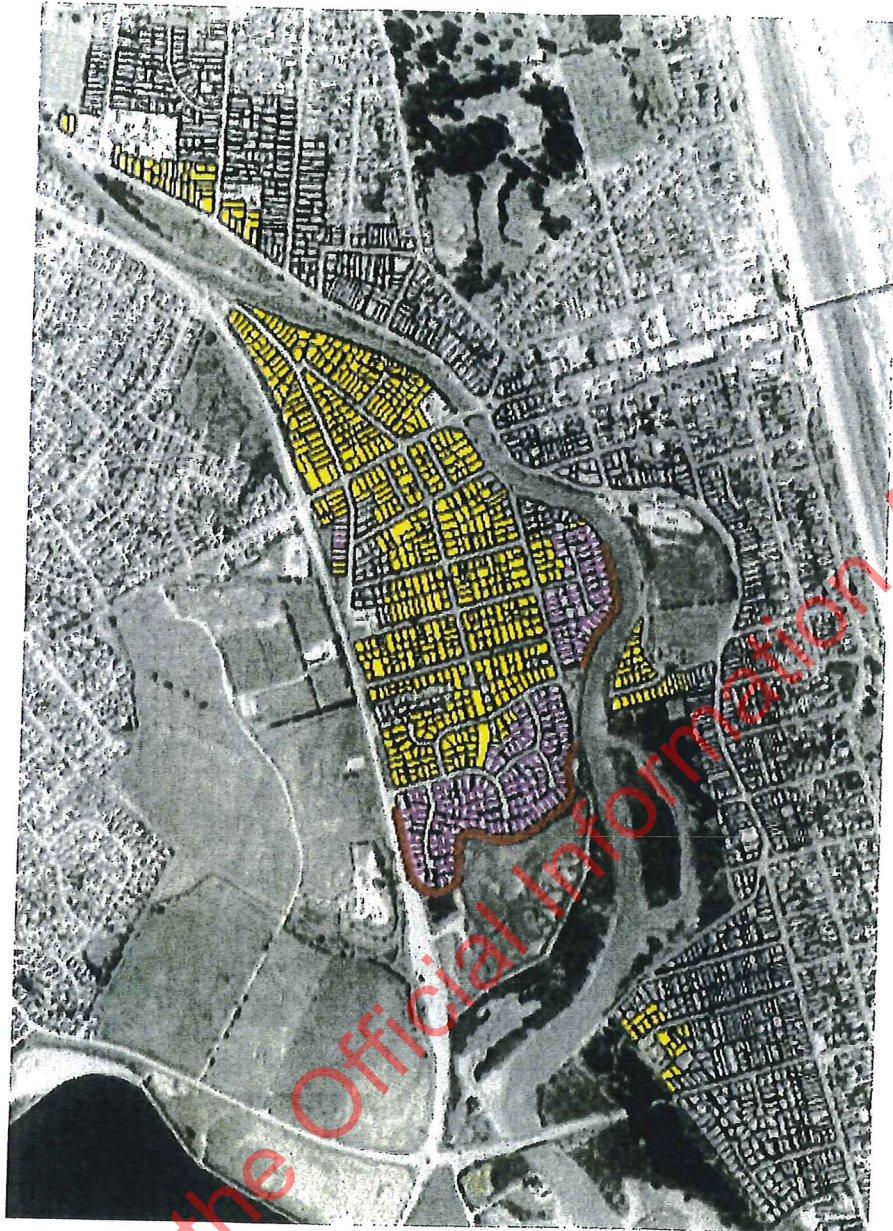
Figure 3.3: Example of Bexley Zone map

For properties in Zone C, repairs to land and buildings (including rebuilding) needs to be co-ordinated. An indicative programme of repair for each of the zones is also included in the Stage 2 report.

An example representation of the land zonation is shown in Figure 3.3.

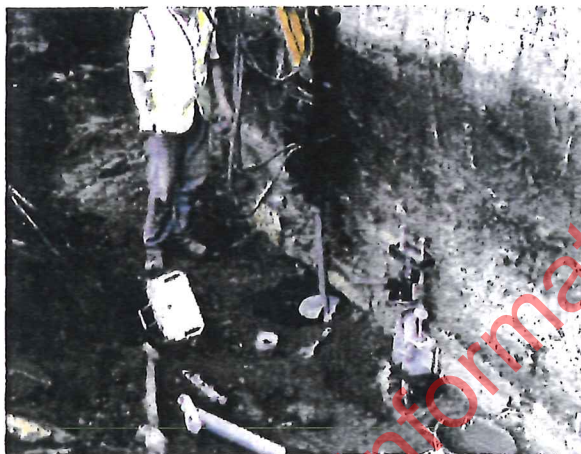
- **Lifting Option 2: Perimeter Foundation Jacking Using Piles (Screw or similar)**

Beam re-leveling using screw piles involves installing piles at discrete locations to the perimeter of the foundation beam, and installing under-beam shoes fitted with jacks to raise the beam to the correct level. With the beam repositioned, flowable grout is introduced to the cavity created under the raised beam. Once the grout is cured the jacks are removed, and the screw piles removed. The screw piles may also be used in a permanent situation.
